COMPLIANCE REPORT

JEMENA NORTHERN GAS PIPELINE (EPBC 2015/7569)

REPORTING PERIOD 20 MAY 2019 TO 19 MAY 2020

Northern Gas Pipeline Transitional Rehabilitation Monitoring Report

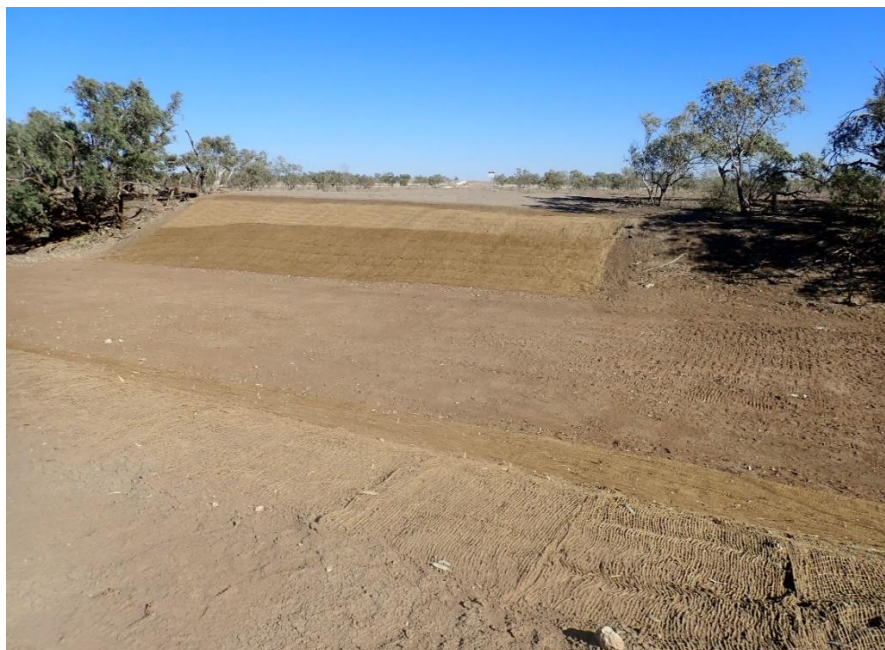
Figure 1: Example of reinstated bank for watercourse crossing at KP431 (29 July 2018)

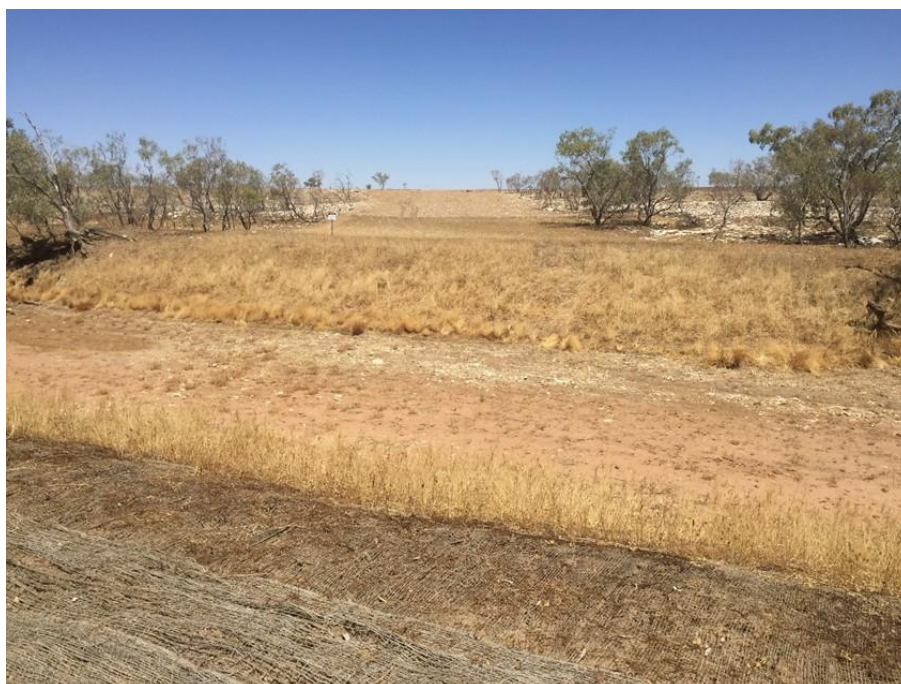
Figure 2. Photograph of the same crossing as above on 19/11/201

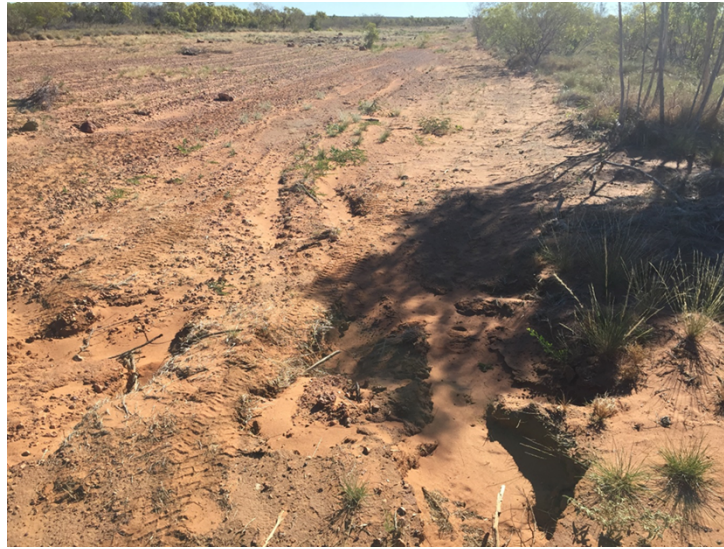
Disturbed areas were stable, with some occurrences of minor water erosion (Figure 3) and slumping (Figure 4). Where these were detected they were repaired. All erosion was modest and was most likely on the track along the ROW. Figure 3 shows some erosion along the track within the ROW, note the vegetation on the ROW on the photo's left-hand-side. Importantly, there was no erosion seen on river banks, with vegetation clearly re-establishing on the banks of major rivers. Figure 5 shows the Georgina River during construction; Figure 6 shows the same location during the defect assessment – note the lack of erosion and the vegetation stabilising the banks.

Figure 3. Photograph of erosion at KP 306

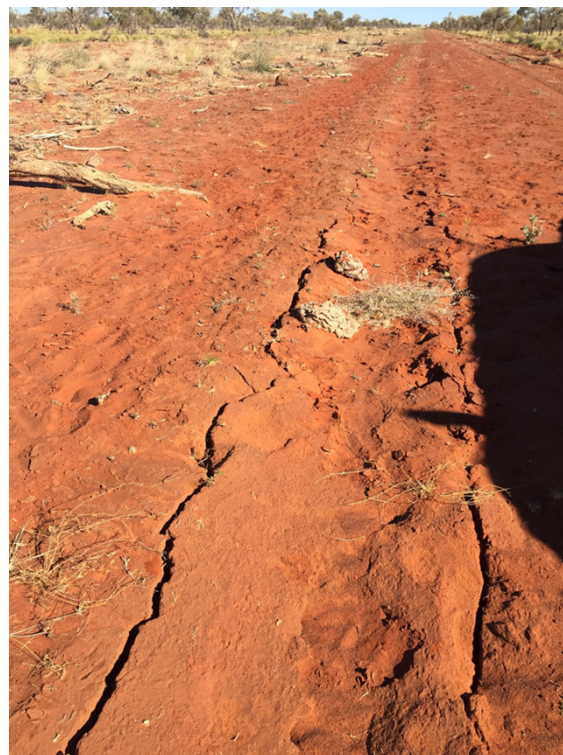
Figure 4. Photograph of slumping at KP 347

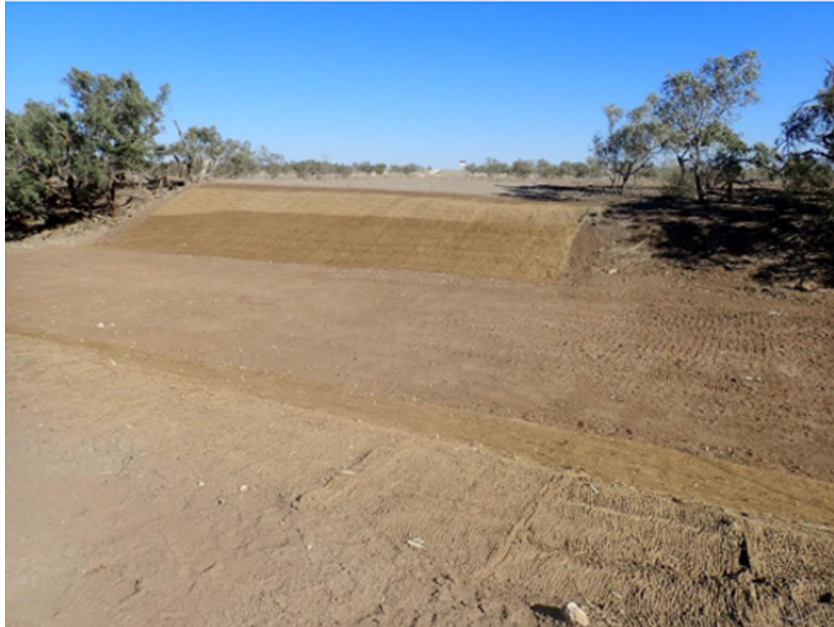
Figure 5. Photograph of Georgina River crossing KP 431 during construction (July 2018)

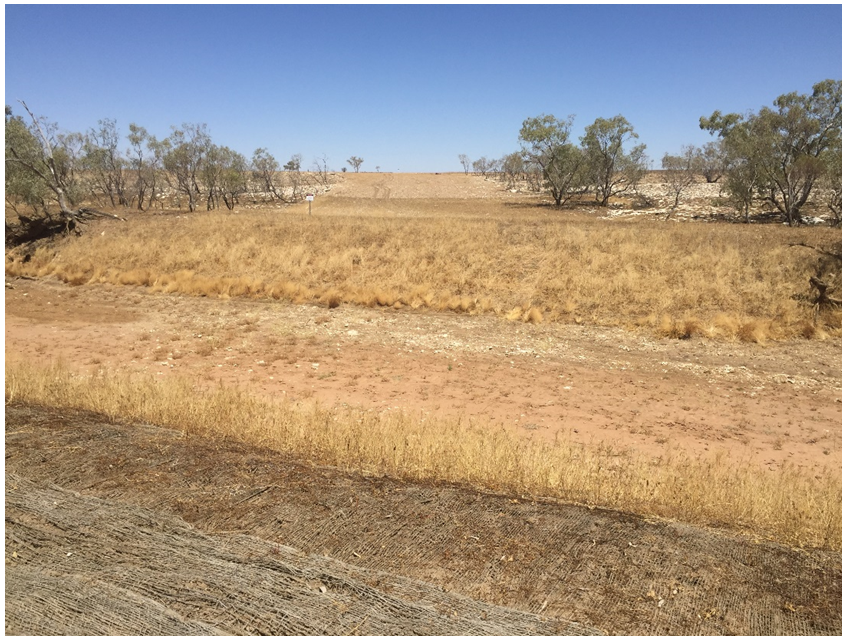
Figure 6. Photograph of the same crossing as above on 19/11/2019

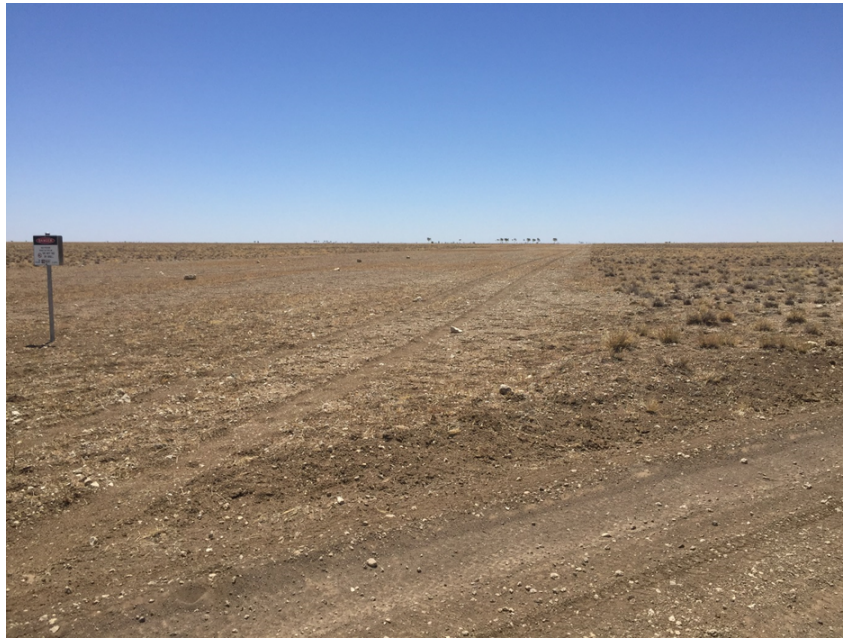
Figure 7. Photograph of KP 468.4 showing re-profiling

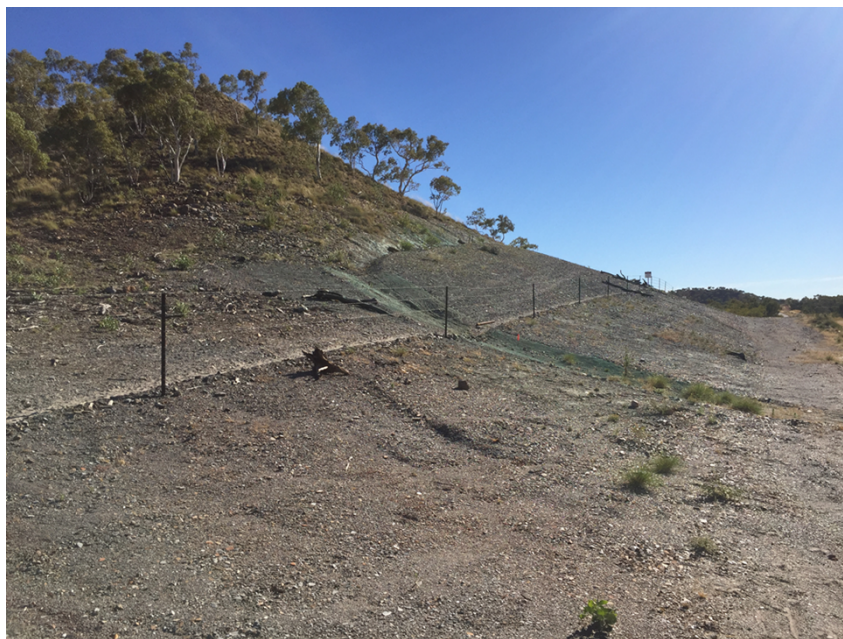
Figure 8. Photograph of KP 618 showing re-profiling on hillside

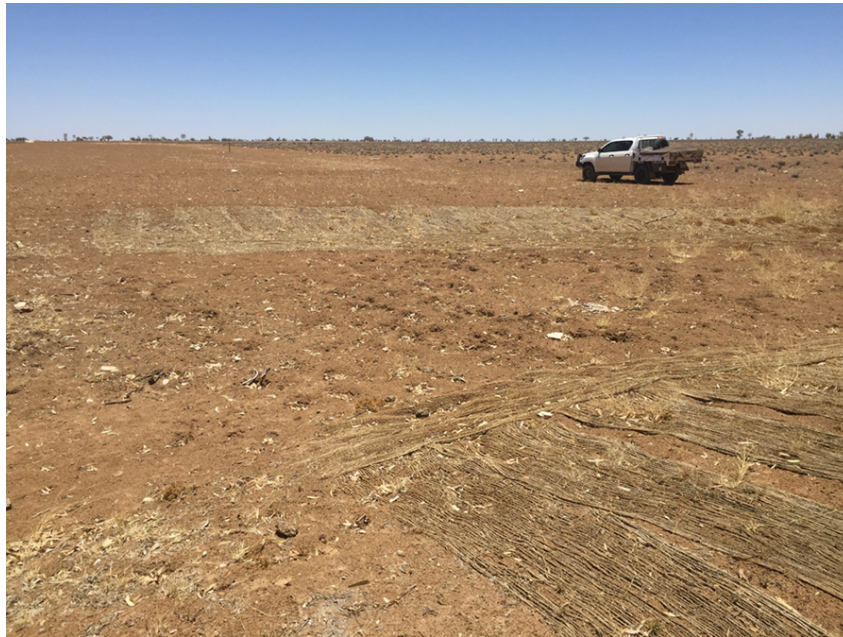
Figure 9. Photograph of a small drainage line at KP 464.9 showing re-establishment

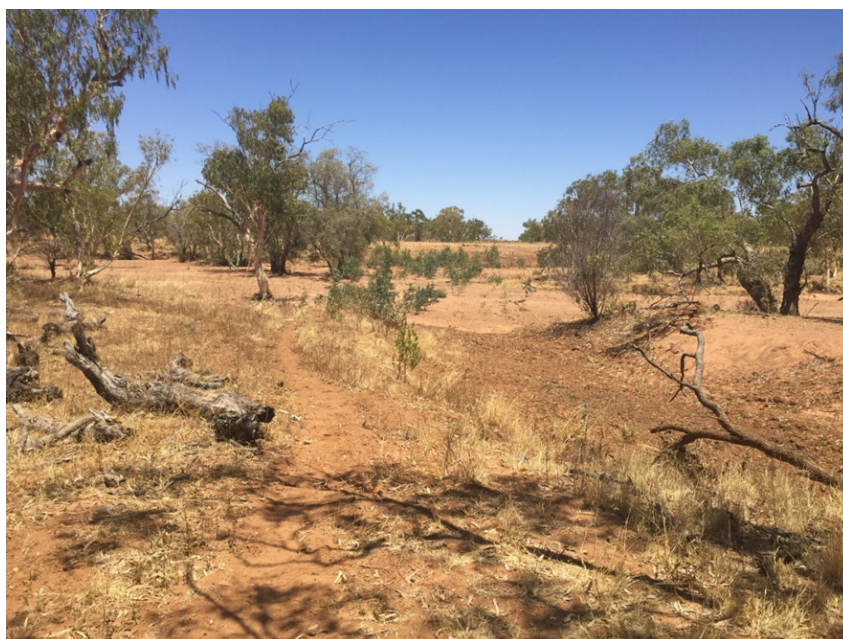
Figure 10. Photograph of the reinstatement of the Templeton River at KP 544.8

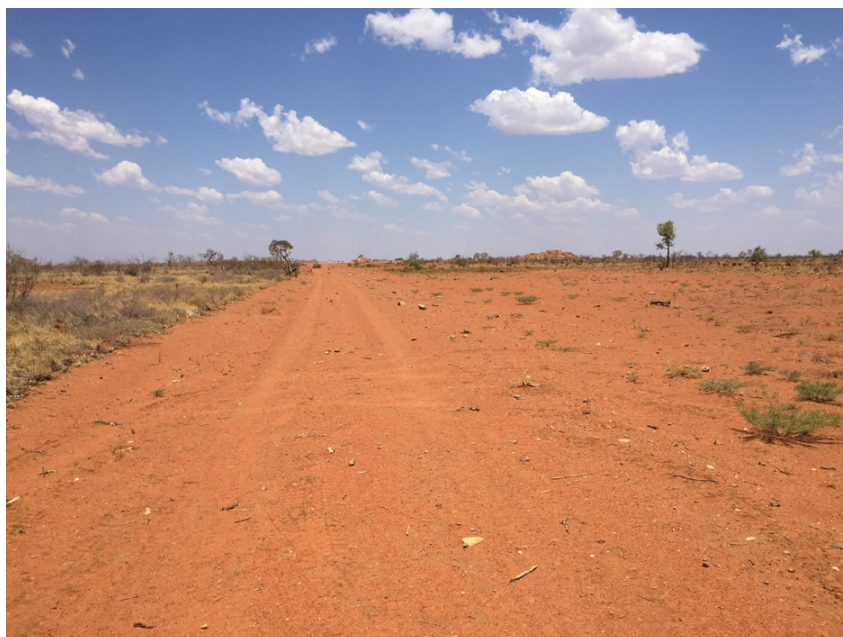
Figure 12. Photograph of ROW (to the right of the access track) showing little vegetation growth (KP 32)

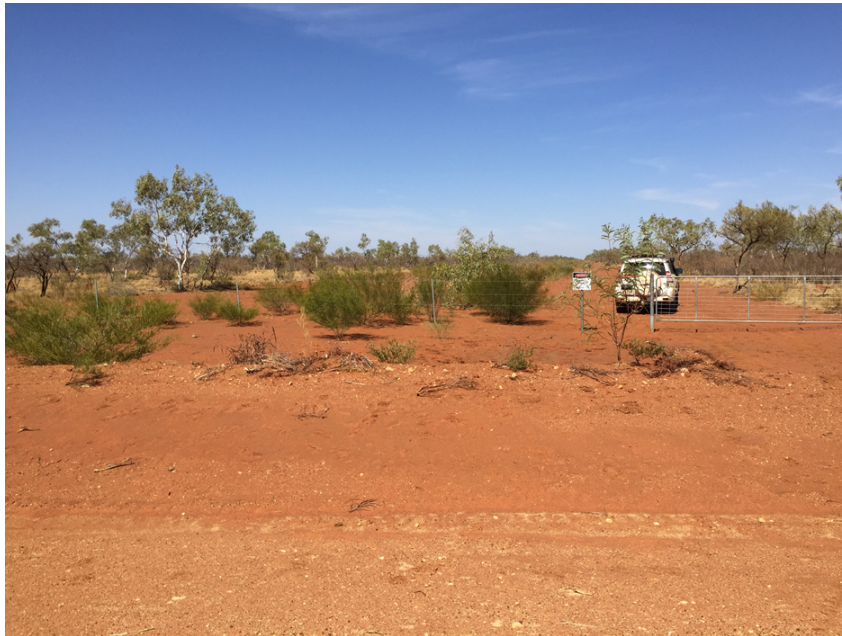
Figure 13. Photograph of ROW at KP 57.6

Notwithstanding the poor wet season in some parts of the NGP project area (Section 2), the ground cover recruitment is quite high across the NGP area. There is variation influenced by rainfall and substrate. At KP 29 there was little vegetation growth on gravelly soils (Figure 11); however, three kilometres away at KP 32 on more loamy soils, there was evidence of ground cover recovering (Figure 12), this was at the drier eastern end of the project area (Section 2). Further east at KP 57.6, growth was much more vigorous (Figure 13) with shrubs well established.

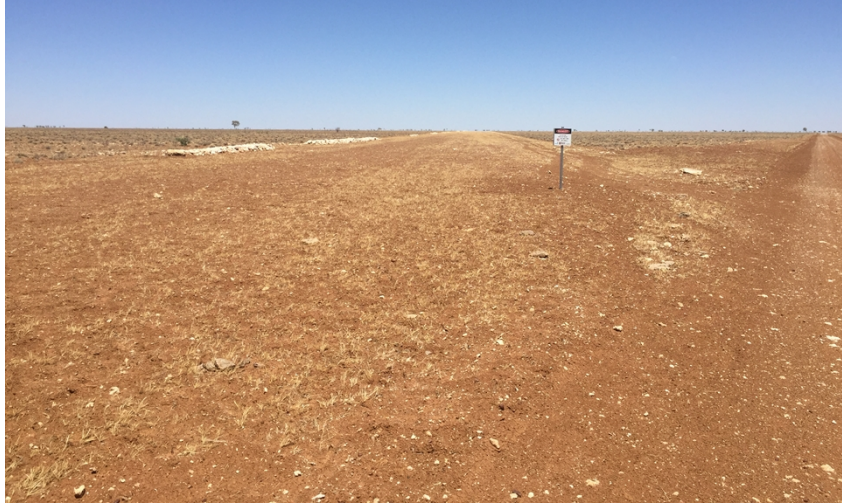
Figure 19. Photograph of KP 468 black soil plains showing tussock grasses returning
