NGP ANNUAL COMPLIANCE REPORT - 2021

Jemena Northern Gas Pipeline Pty Ltd (ACN 607 928 790)

JEMENA
NORTHERN GAS PIPELINE
TRANSITIONAL REHABILITATION ASSESSMENT
REPORT

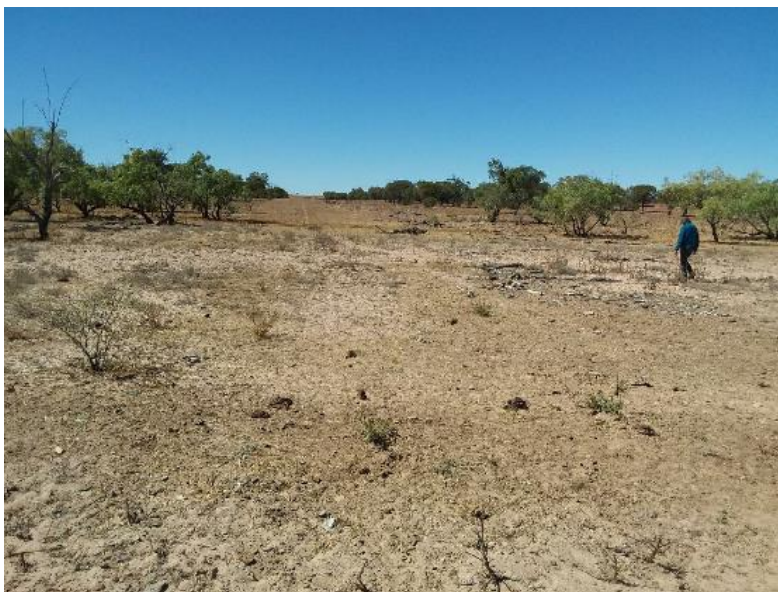
Figure 6: Prickly Acacia and Noogoora Burr establishing within ROW on eastern flood-out overbank of Six Mile Creek (KP 383.5).

It is recommended that Jemena continue to undertake control of areas of weed incursion within the disturbed areas. Jemena should also consider working with adjacent landholders to control weeds immediately adjacent to the pipeline ROW to reduce likelihood of spread from adjacent land onto the ROW. Control of declared weeds within the ROW should be prioritised. Future monitoring should reinspect these locations to ensure control has been effective and weeds have not spread.

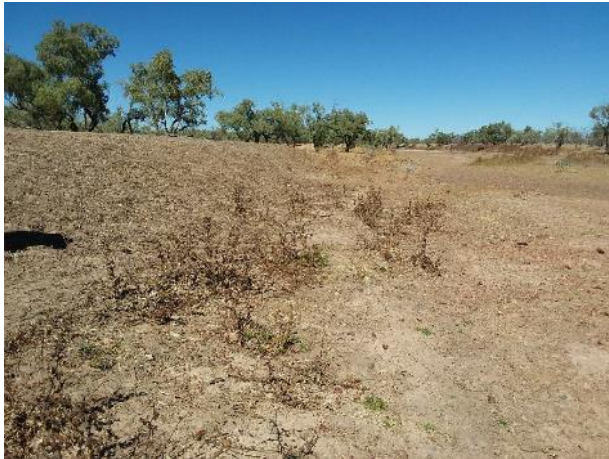
Figure 7: Noogoora Burr established along the foot of the bank of Six Mile Creek within the ROW (KP 383.5).

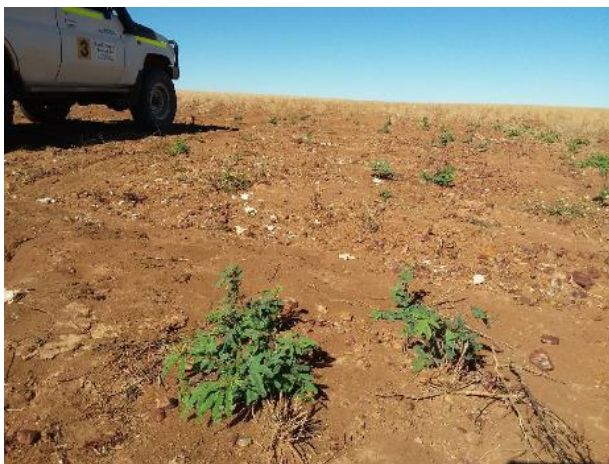
Figure 8: Farnesiana establishing in a small depression within ROW east of creekline (KP 424.1).

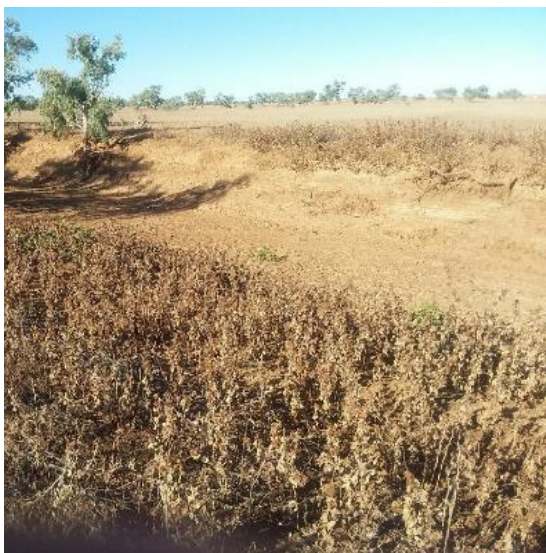
Figure 9: Noogoora Burr established along creek banks within ROW in QLD (KP 472).

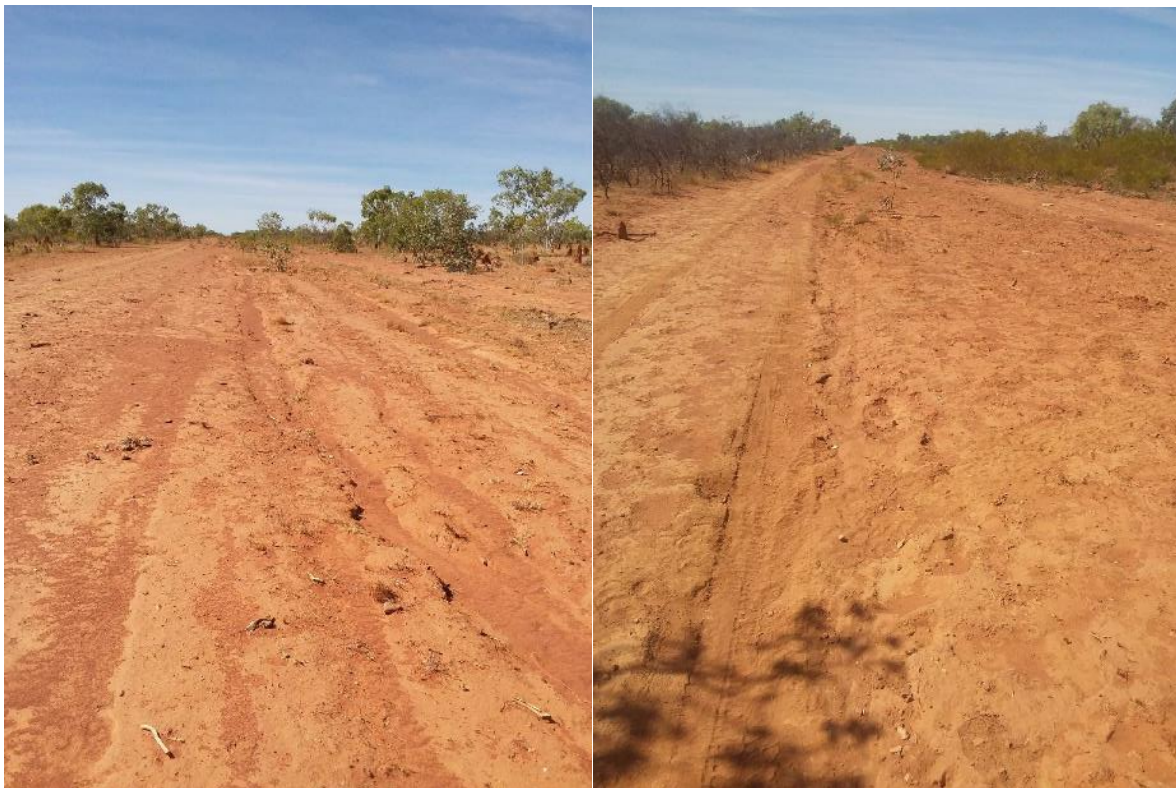
Figure 11: Minor shallow rill erosion (KP 24.7 & KP 27.4)

- Monitor minor erosion occurrences.
- Where appropriate, fill and smooth moderate erosion occurrences to prevent further advancement and encourage vegetation to establish. Eroded sediment from downslope could be used where available.
- Repair compromised berms, and extend and make them more robust as appropriate.
- Construct additional berms as required upslope of areas where erosion is developing due to water channelling along ROW/track.

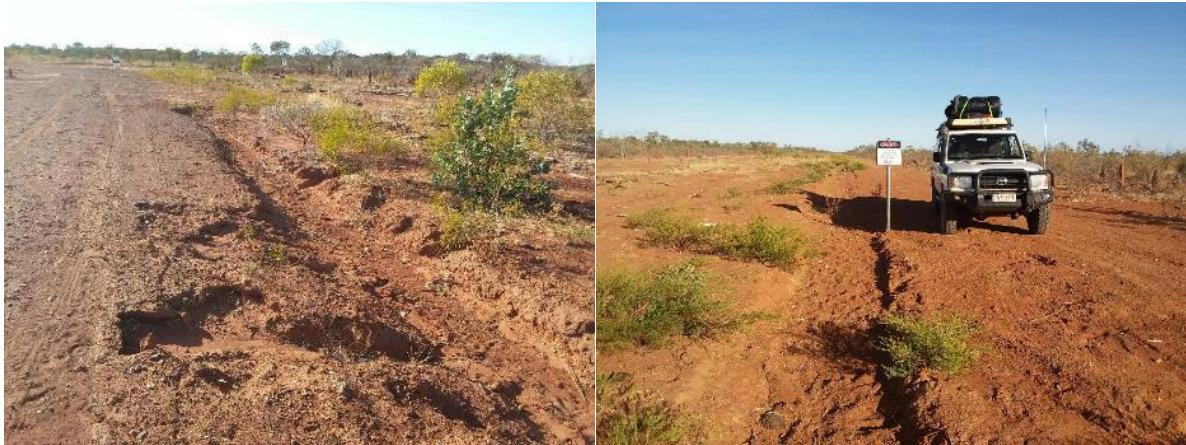
Figure 12 Moderate Channelling Erosion, note water tracking down pipe trench (KP 7.6)

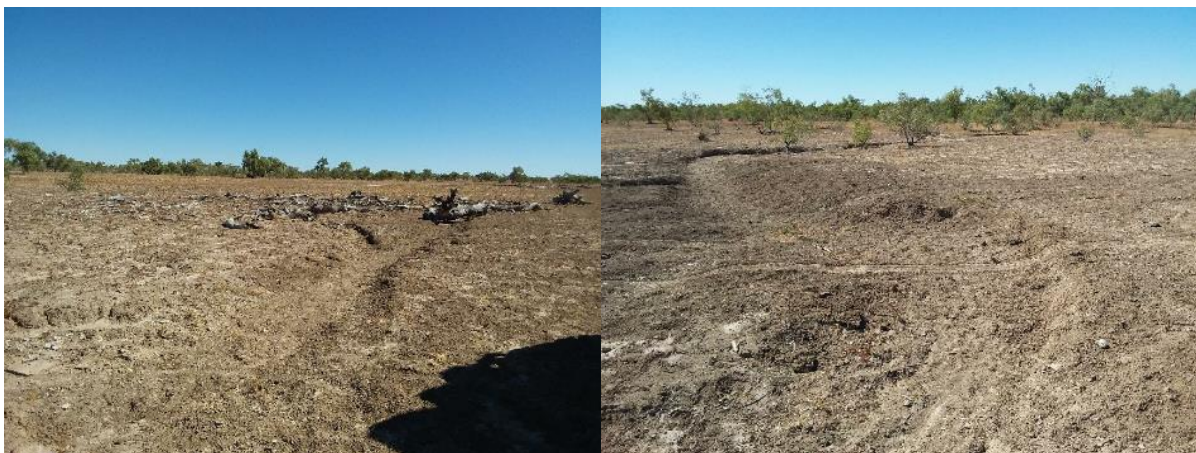
Figure 13 Moderate Extensive Erosion (KP 410.3)

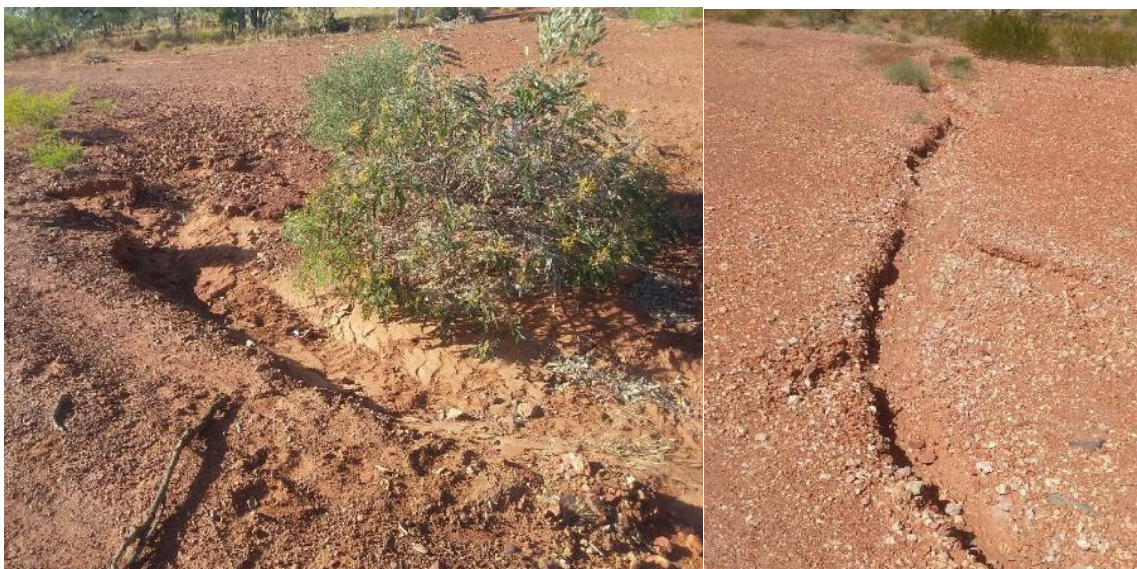
Figure 14 Moderate Localised Erosion (KP 8.4 & KP 29.3)

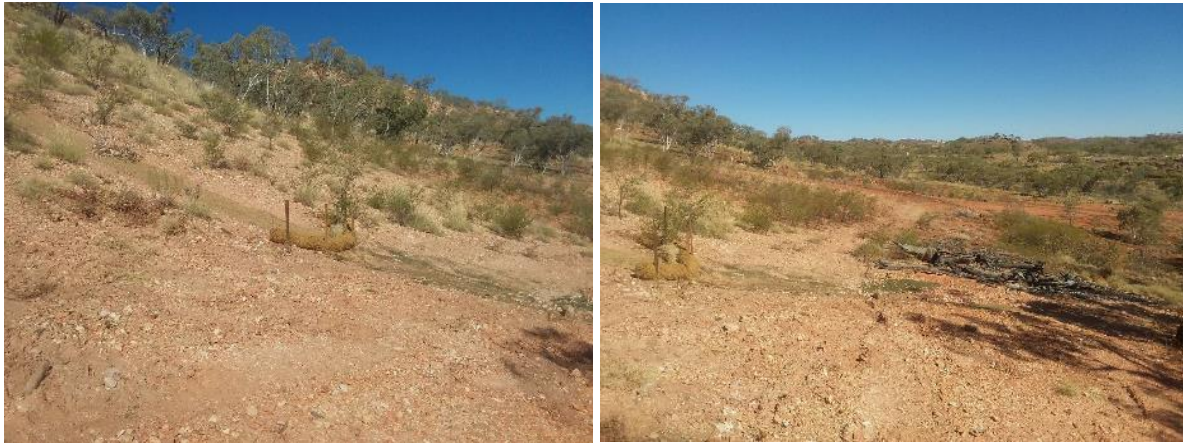
Figure 15 Water diversion trench on slope at ~KP 620

In the Barrier Range at approximately KM 620 the water diversion channel at the top of the slope above the recent repairs should be filled (refer Figure 15) the water is pooling and collectively travelling down the rocky slope, causing an erosion gully to develop (refer Figure 16). Filling the water diversion channel would allow the water to surface flow across the repaired area preventing further erosion and encouraging vegetation growth which would aid in land stabilisation.

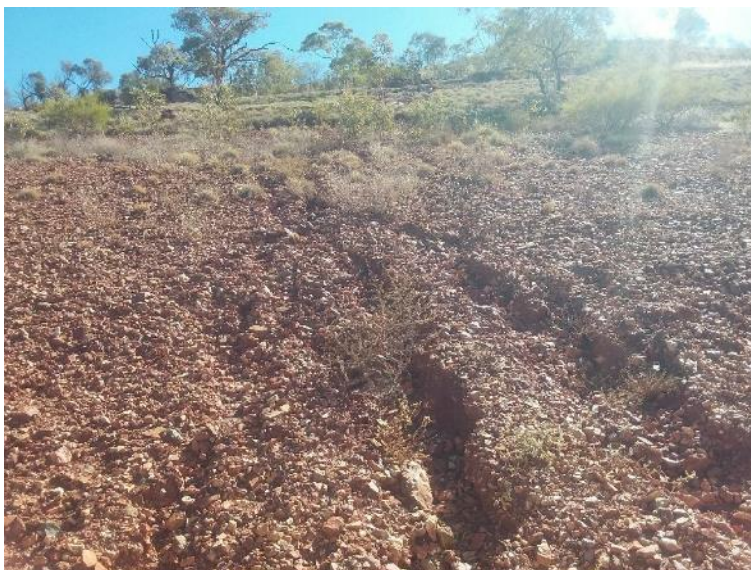
Figure 16 Erosion Gully forming down slope at ~KP620

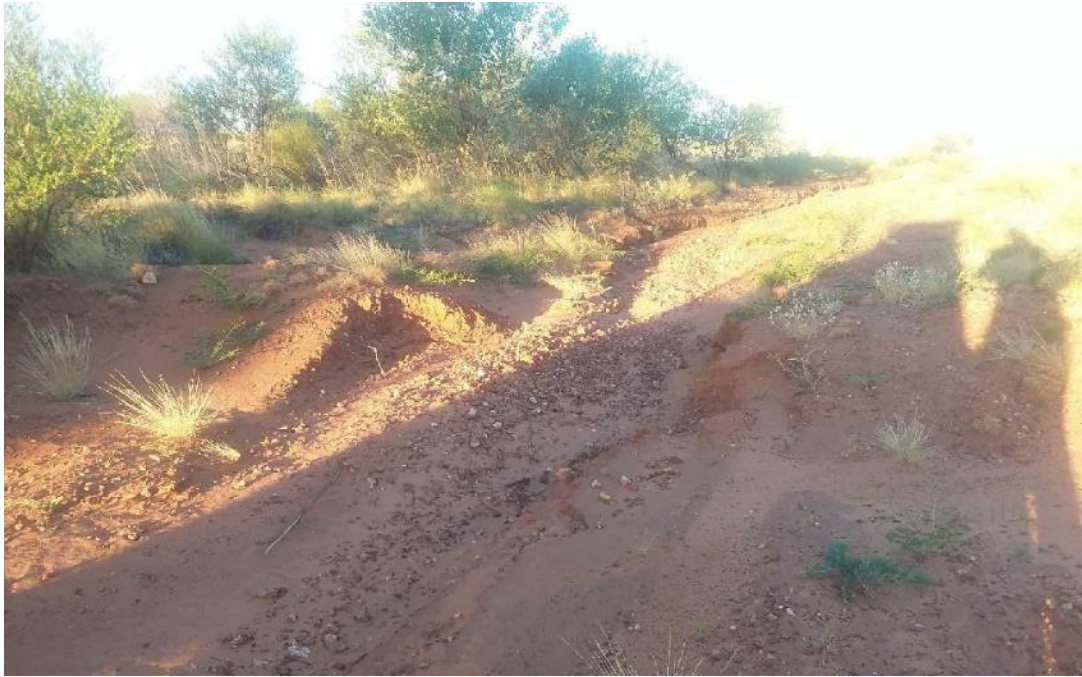
A significant number of berms have been compromised and are no longer serving their purpose. Damage was most often due to water erosion, resulting in erosion channels through the berms (refer figure Figure 18). There were several occurrences of water flowing around the ends of berms and back onto the pipeline ROW rather than diverting outwards into adjacent land. This was often due to berms not extending far enough at edges of ROW. Cattle tracking has also caused erosion of berms in places creating water pathways through berms.

Figure 18 Berm completely eroded through and erosion developing in track (KP 306.6)

- Repair existing compromised berms, and make them more robust as appropriate.
- Extend most of the berms, to more effectively divert water beyond the ROW. Currently water is often flowing around the end of the berms and continuing down the track.
- Construct additional berms in areas with susceptibility to water flow and erosion.
- Raise the height of some of the berms to dissuade cattle.

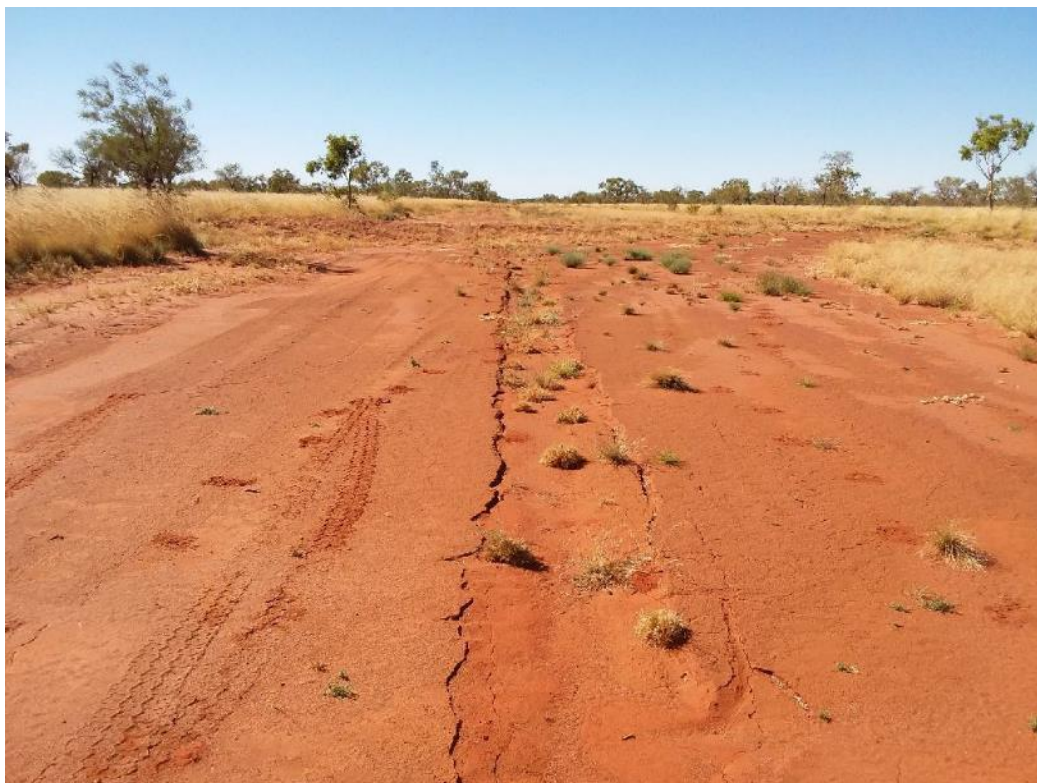
Figure 20: Minor Subsidence

- Where appropriate, back fill subsidence to ground level.
- Repair nearby berms and/or add additional berms up slope of subsidence locations where water has been tracking along subsided trench.

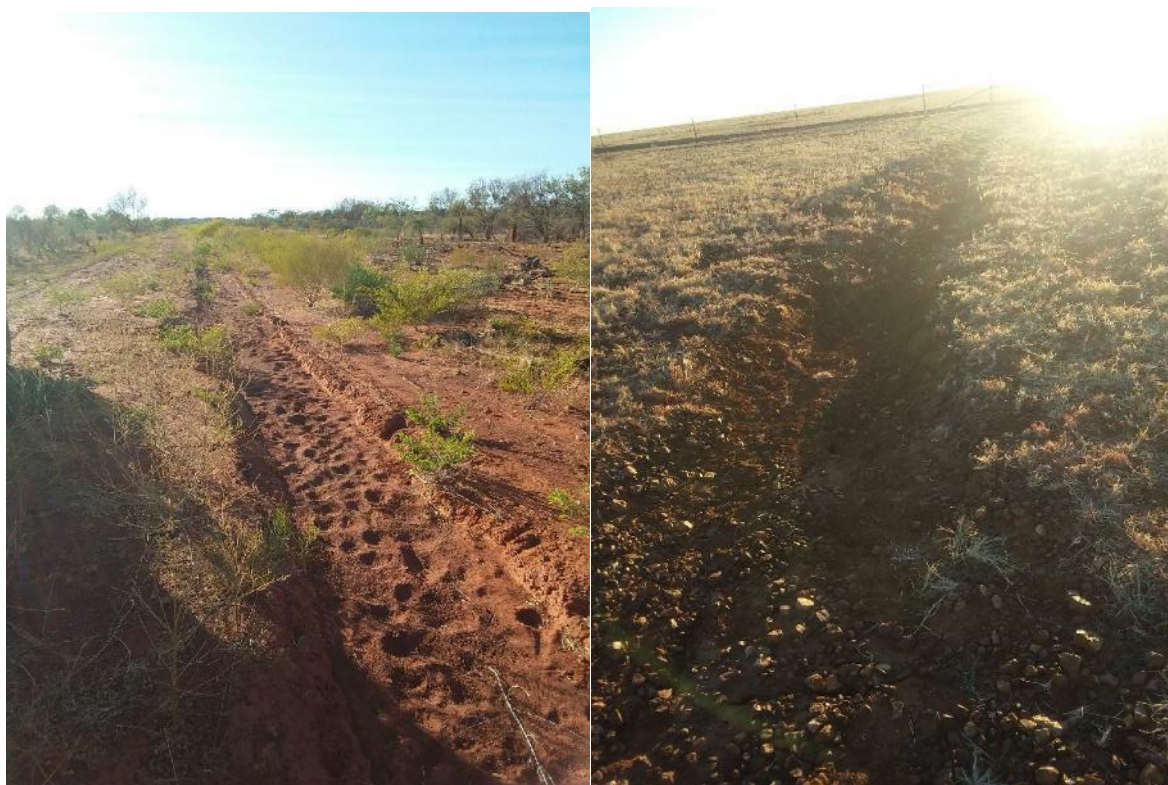
Figure 21: Moderate subsidence with water channelling and potential to erode further

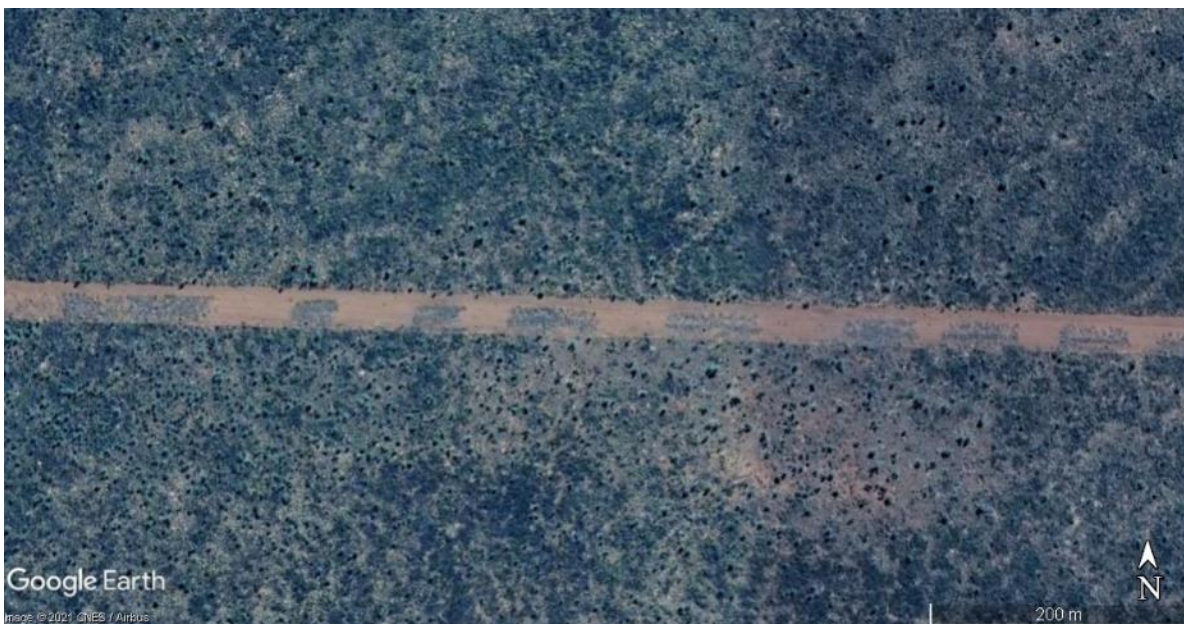
Throughout the ROW there is a recurring pattern of distinct areas with little or no revegetation. These areas, characterised by bare ground or regrowth restricted to annual grasses, are visible in the aerial photograph shown below and the survey photographs taken at the same location. These areas may be caused by the methods used in the redistribution of top soil and vegetation following the initial construction phase. Further action may be required to ensure that these areas revegetate to the same standard as the rest of the site and meet the transitional rehabilitation criteria. It is suggested that a process of ripping along contours is used to encourage water retention and allow endemic seeds to be captured in these areas to encourage revegetation.

Figure 23. aerial photograph of areas without revegetation taken at place mark 68

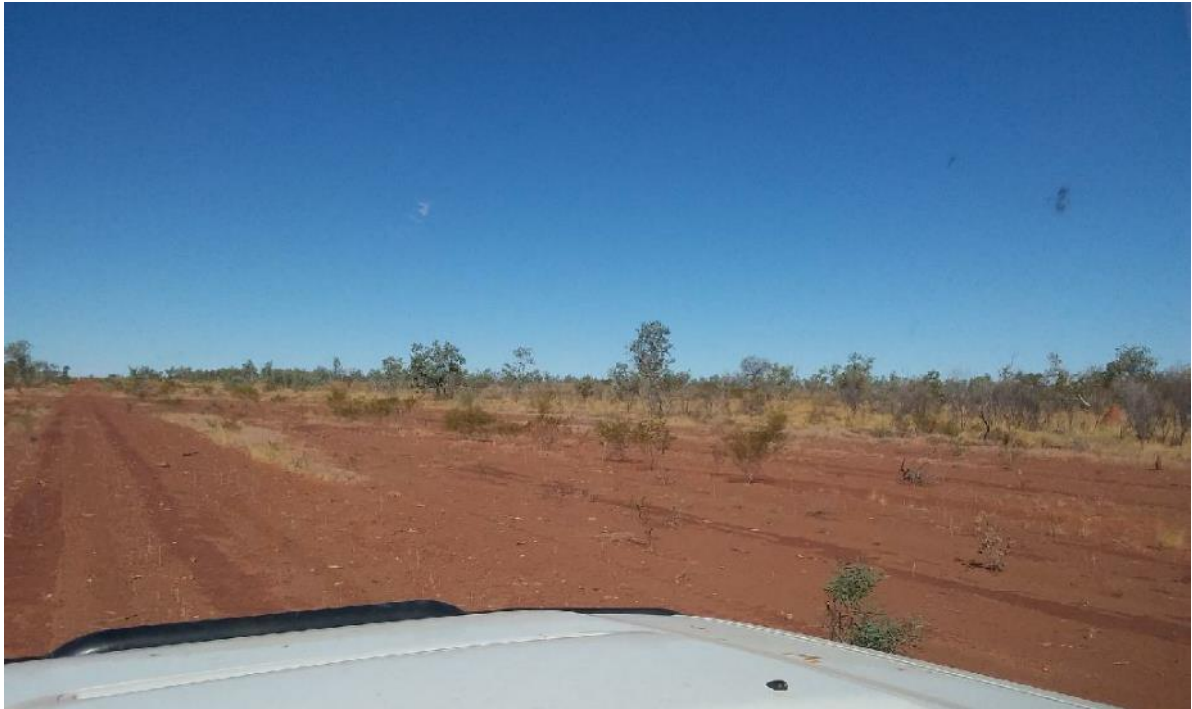
Figure 24. photograph of area without vegetation taken at placemark 68

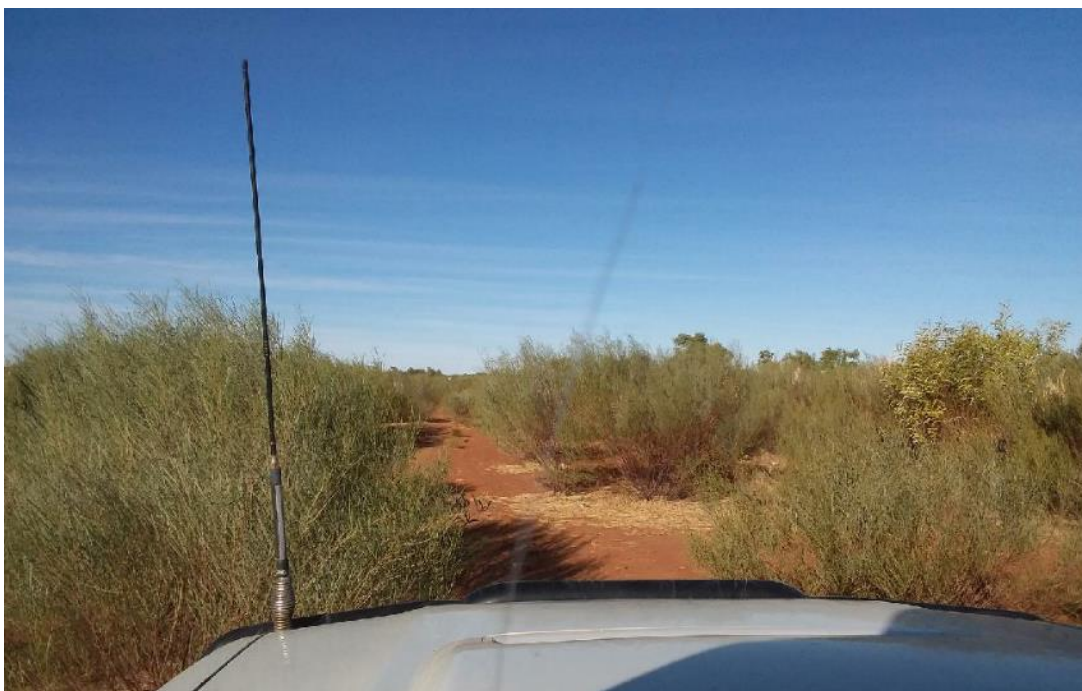
Intermittently along the ROW, particularly across the Wonorah land system, *Eucalypt spp*, up to 4 metres tall have seeded and grown directly over the pipeline. These trees map negatively impact the asset in the future and management action is suggested to mitigate this risk. Similarly in some areas extremely dense Acacia stands are likely to obstruct access to the track alongside the pipeline (figure 25 and 26). *Acacia lysiphloia*, *Acacia colei* and *Acacia stipuligera* all occur in very dense clumps in some areas of the ROW and are already encroaching on the pipeline access track. Future management actions may be required to ensure that the entirety of the ROW remains accessible.

Figure 25. dense growth along pipeline

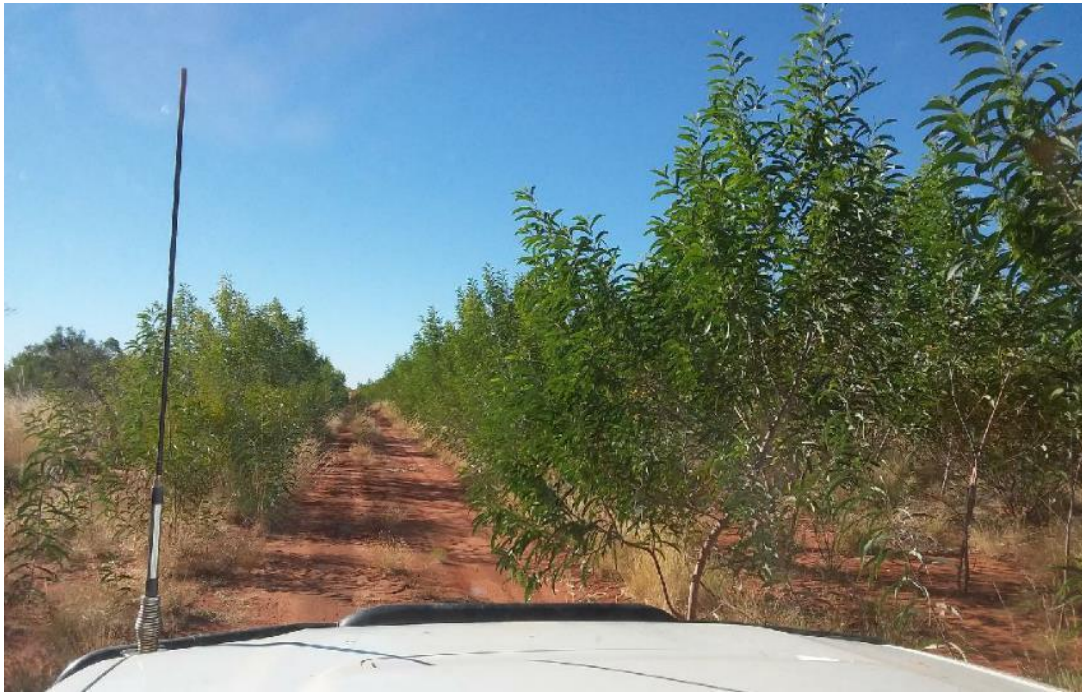
Figure 26. dense *Acacia Colei* along ROW

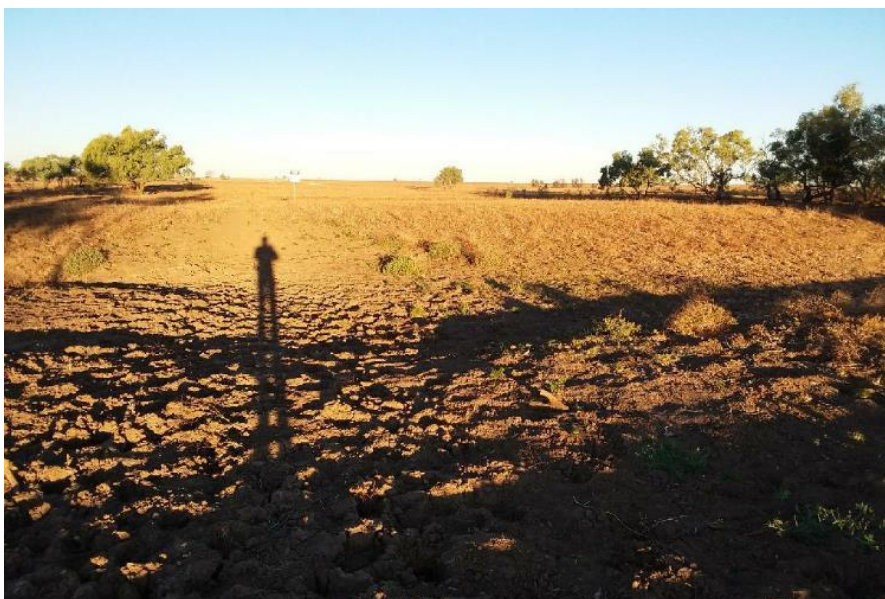
Throughout the ROW cattle tracking through the revegetating areas is negatively impacting plant reestablishment. This is particularly notable in the cracking clay Mitchell grass plains area where cattle tracks have stopped Mitchell grass from regrowing along the ROW and at some water courses where cattle tracking may lead to destabilisation. It is suggested that some type of physical barrier is constructed at watercourse locations to prevent stock from preferentially using the ROW in these areas and therefore causing significant loss of vegetation and stability.

Figure 27: River generally in good uneroded condition. Cattle impacting stabilisation and revegetation in part of easement (left of photo). Well vegetated except where cattle have trampled and pugged (KP 451.2).
