NGP ANNUAL COMPLIANCE REPORT - 2023

JEMENA
NORTHERN GAS PIPELINE
TRANSITIONAL REHABILITATION ASSESSMENT
REPORT 2023

June 2023

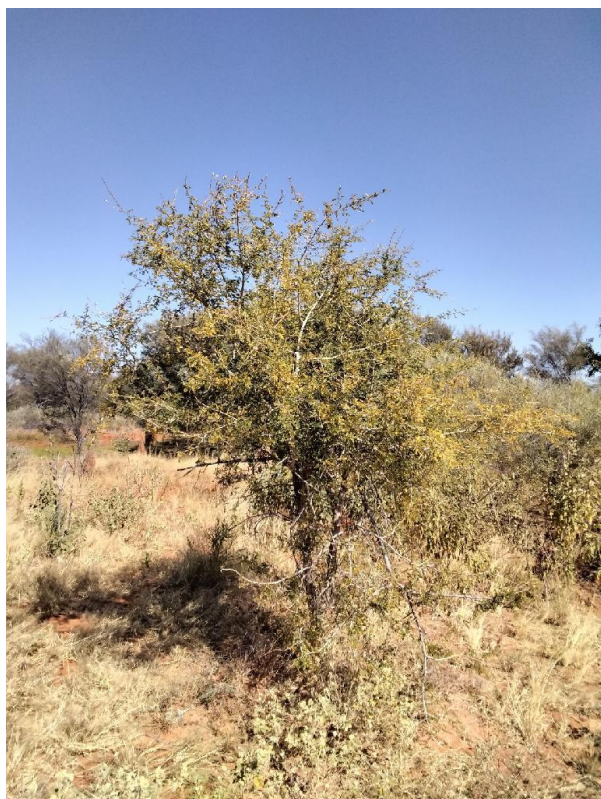
Figure 6. Mesquite within Railway corridor and NGP easement at KP 15.6

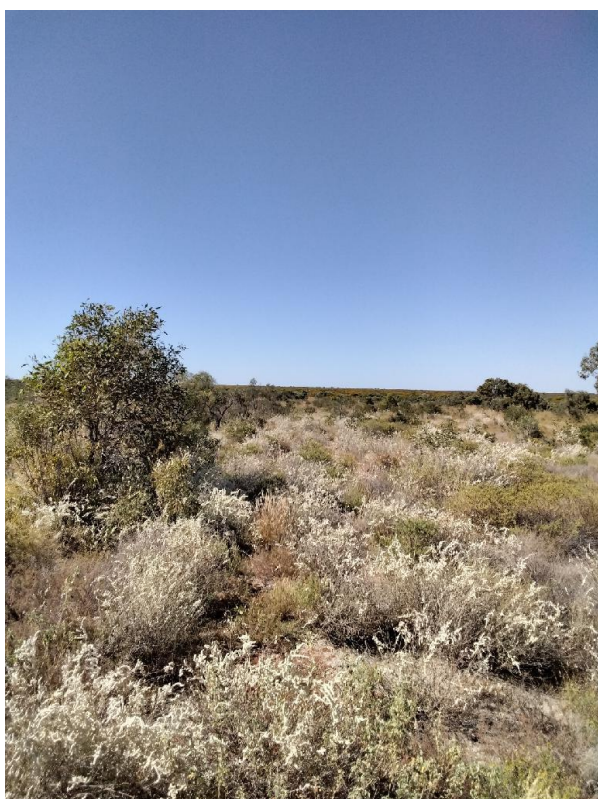
Aerva javanica (Kapok Bush) was the most extensive weed found throughout the ROW, having spread from adjacent land at KP 224 and KP 226.9 to form moderate to dense populations within the ROW. In the eastern portion of the ROW, from KP 575.2 to the end of the pipeline, Kapok Bush was consistently recorded in moderate to high density populations spreading along the pipeline easement and into adjacent vegetation.

Figure 7. A 50m stretch of dense Kapok Bush within the easement at KP 234.1

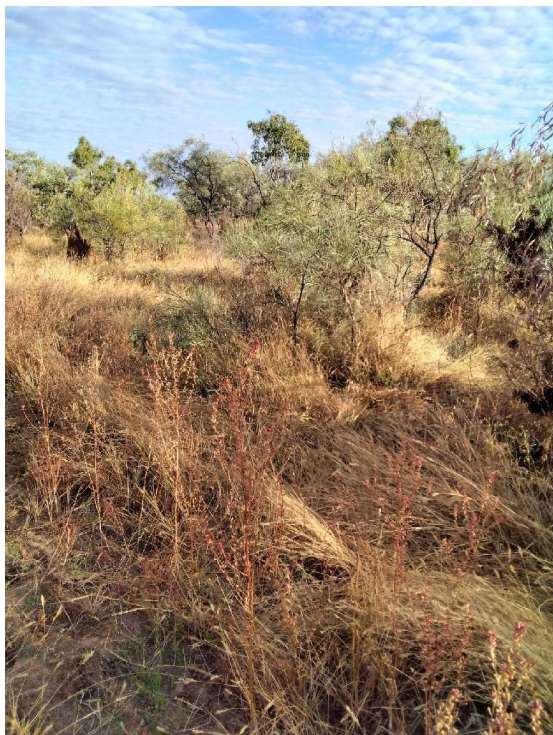
Hyptis suaveolens (Hyptis/Horehound) was found to be spreading into the pipeline easement from adjacent land at three locations; KP 62.7, KP 63.6 and KP 87.2. These occurrences were moderate to low density populations.

Figure 8 . Hyptis spreading from adjacent land into the easement at KP 62.7

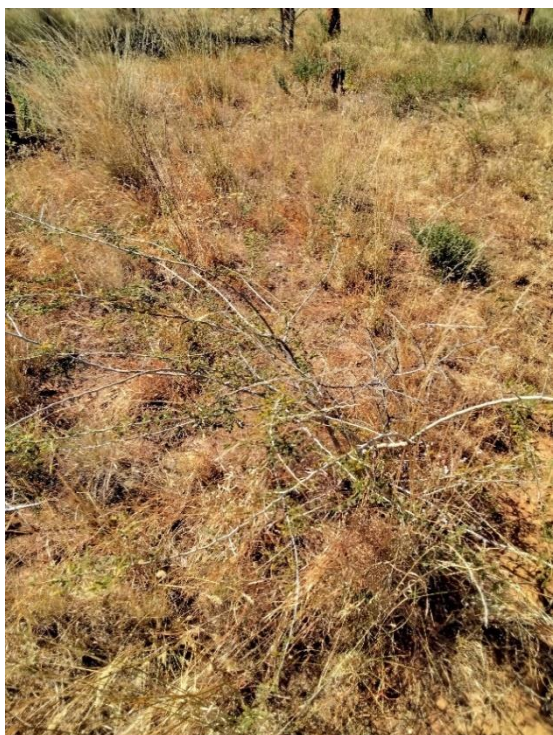
Vachellia farnesiana (Farnesiana) was found in sparse patches along the easement at KP 401.8, KP 415.3, KP 426.6, KP 475.5 and KP 509.9, having spread from adjacent land and now establishing within the easement.

Figure 9. A partially defoliated Farnesiana at KP 401.8.

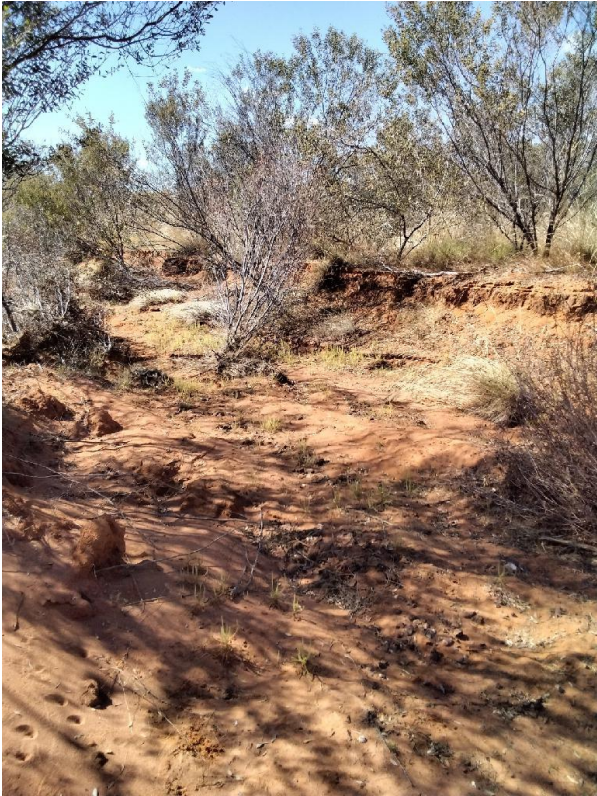
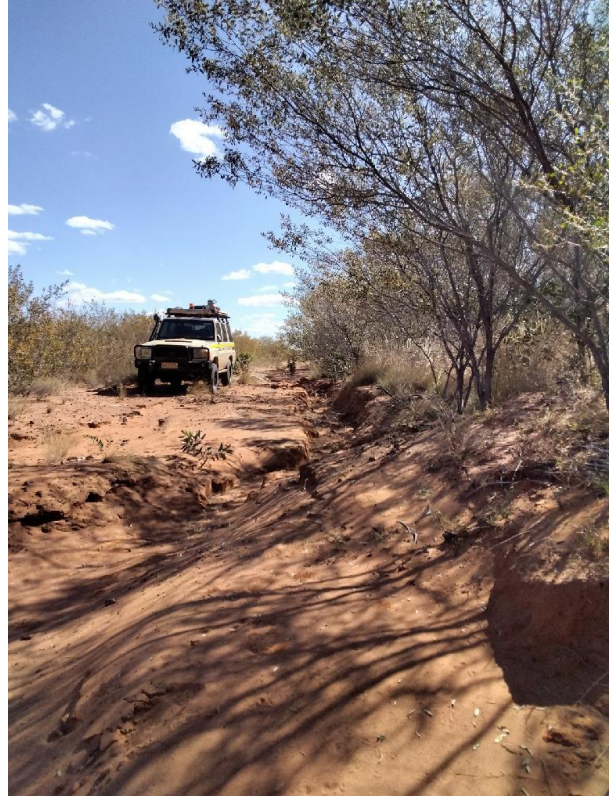
Figure 11. Significant erosion with over 700mm deep gully erosion KP 267.5

57	Moderate Erosion	266.8		3	Address moderate erosion issues
58	Moderate Erosion	267.5		3	Repair Berm and address moderate erosion issues
103	Moderate Erosion	268.6		3	Address moderate erosion issues
104	Compromised Berm (Moderate)	270.1		3	Repair Berm and address moderate erosion issues
105	Compromised Berm (Moderate)	270.5		3	Repair Berm and address moderate erosion issues
59	Moderate Erosion	271.1		3	Address moderate erosion issues
60	Moderate Erosion	271.9		3	Address moderate erosion issues
106	Significant Erosion; Compromised Berm (Significant)	272.2		1	Repair Berm and address significant erosion issues
107	Moderate Erosion	272.4		2	Install new Berm/s and address moderate erosion issues
61	Significant Erosion	272.6		1	Install new Berm/s and address significant erosion issues
108	Compromised Berm (Moderate)	272.6		2	Repair Berm and address moderate erosion issues
63	Moderate Erosion	274.4		3	Address moderate erosion issues

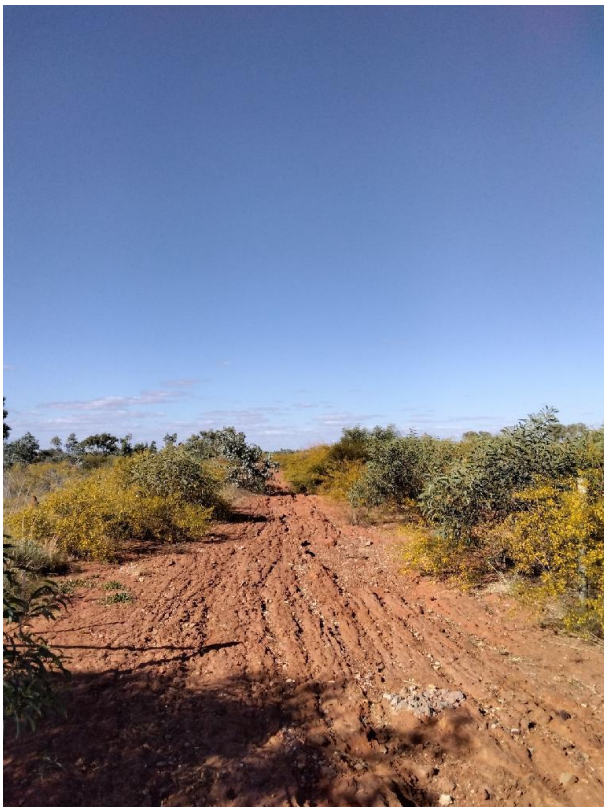
Figure 12. Moderate rill erosion at KP 45.9

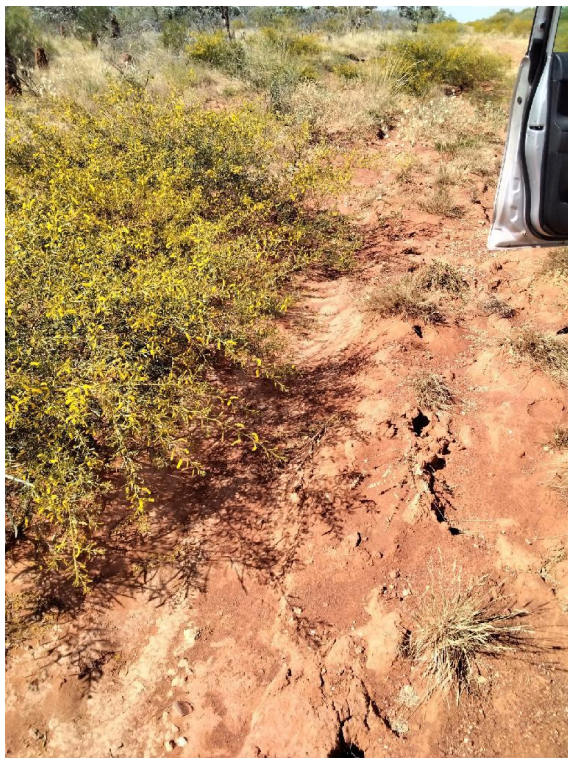
Figure 13. Moderate gully erosion up to 300mm deep at KP 29.3

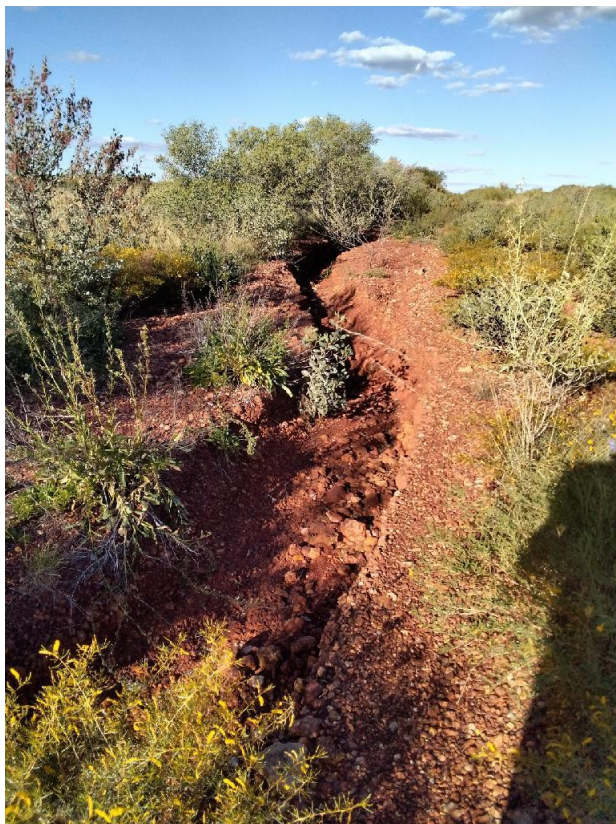
Figure 14. Significant erosion up to 1m deep at KP 298.5

76	Moderate Erosion	295.5		3	Install new Berm/s and address moderate erosion issues
470	Moderate Subsidence	297.8		3	Address moderate subsidence issues
471	Minor Erosion	298.2		4	Monitor minor erosion
472	Significant Erosion	298.5		1	Install new Berm/s and address moderate erosion issues
407	Moderate Erosion	303.5		3	Install new Berm/s and address moderate erosion issues
473	Moderate Erosion	306.6		2	Install new Berm/s and address moderate erosion issues
474	Minor Erosion	308.1		3	Install new Berm/s and address minor erosion issues
475	Compromised Berm (Moderate)	309.5		2	Repair Berm and address moderate erosion issues
77	Compromised Berm (Moderate)	313.1		3	Repair Berm and address moderate erosion issues
78	Moderate Erosion	313.4		3	Address moderate erosion issues
79	Minor Erosion	317.1	Culturally Sensitive	4	Monitor minor erosion
110	Minor Erosion	317.9		4	Monitor minor erosion
111	Moderate Erosion	318.2		3	Address moderate erosion issues

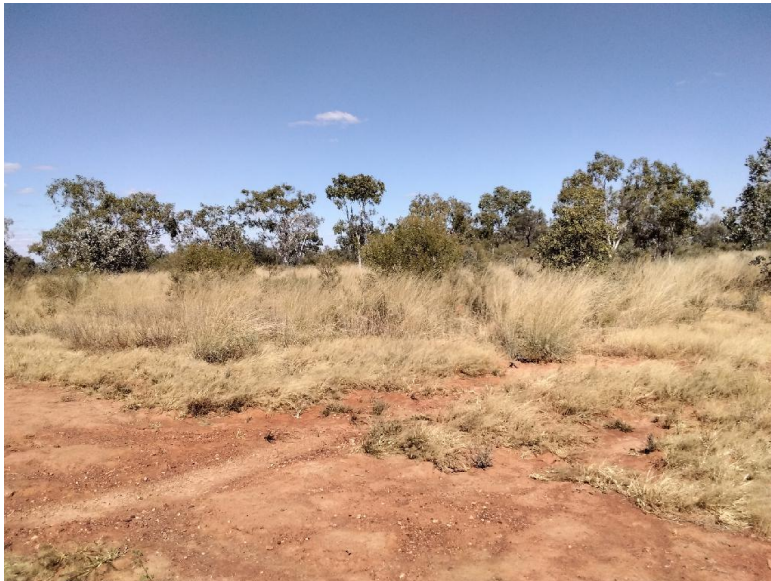
Figure 15. Minor erosion across track and revegetation at KP 24.1

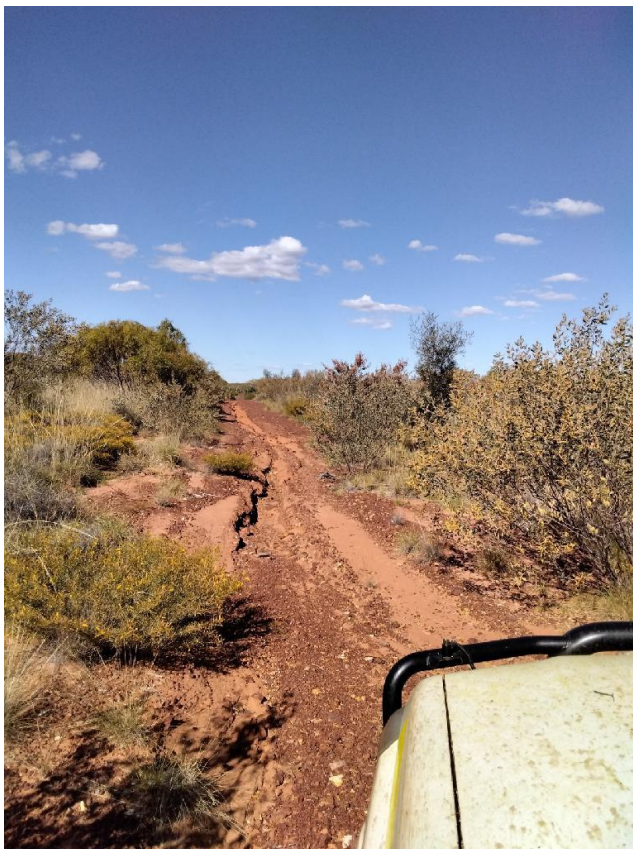
Figure 16. Significant rill erosion up to 500mm deep for approximately 200m at KP 272.6

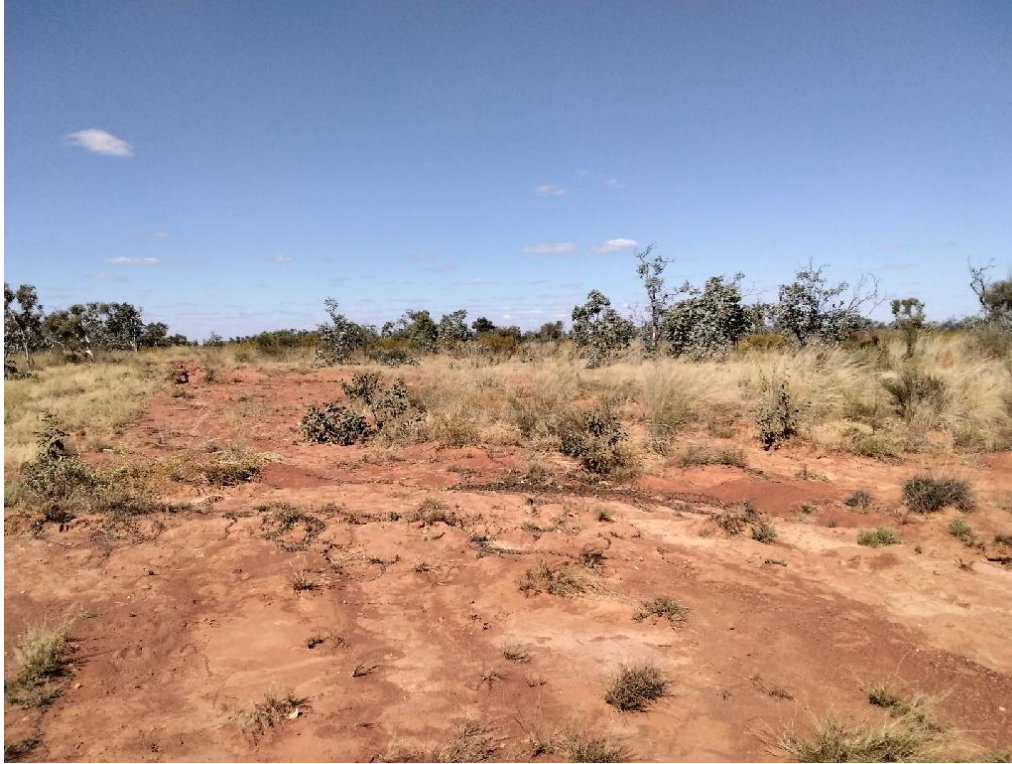
Figure 18. Compromised berm resulting in moderate erosion at KP 25

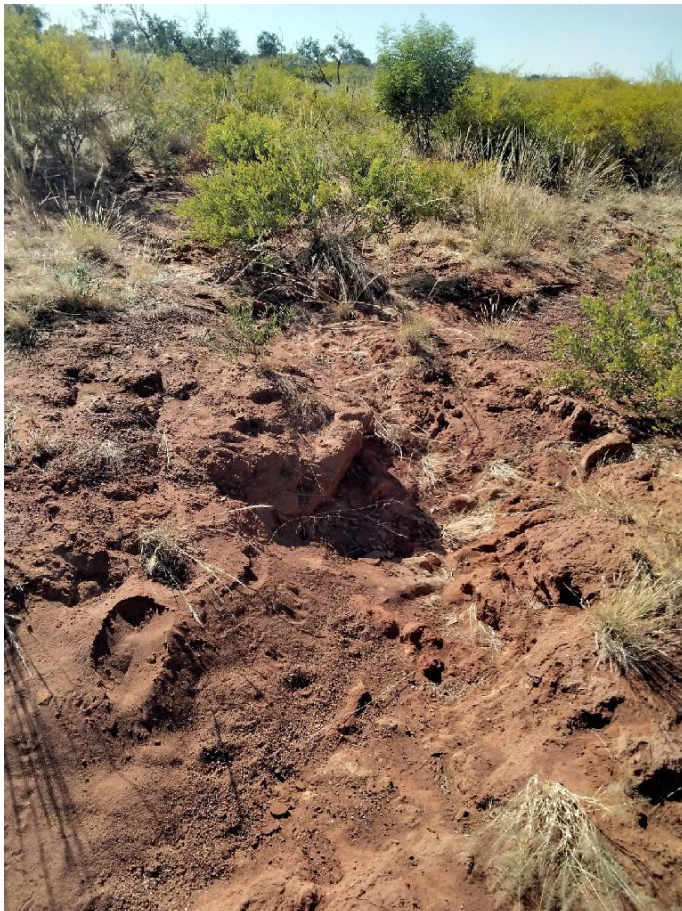
Figure 19. Failed berm with significant erosion at KP 7.5

415	Significant Subsidence	7.5		1	Install new Berm/s and address significant erosion issues
416	Compromised Berm (Significant)	7.5		1	Repair and Extend Berm
417	Significant Subsidence	7.6		1	Address significant erosion issues
543	WONS (Mesquite)	7.8		NA	Remove WONS occurrences
418	Significant Subsidence	7.9	Culturally Sensitive	1	Address significant erosion issues within the easement
419	Significant Subsidence	8.2	Culturally Sensitive	1	Address significant erosion issues within the easement
420	Significant Erosion	8.6	Culturally Sensitive	1	Install new Berm/s and address significant erosion issues within the easement
421	Compromised Berm (Significant)	8.8		1	Repair Berm
422	Compromised Berm (Significant); Significant Erosion; Significant Subsidence	9.2	Culturally Sensitive	1	Repair Berm, add Berm/s, Fill and Smooth and address significant erosion issues within the easement
423	Minor Erosion	9.5	Culturally Sensitive	4	Monitor minor erosion

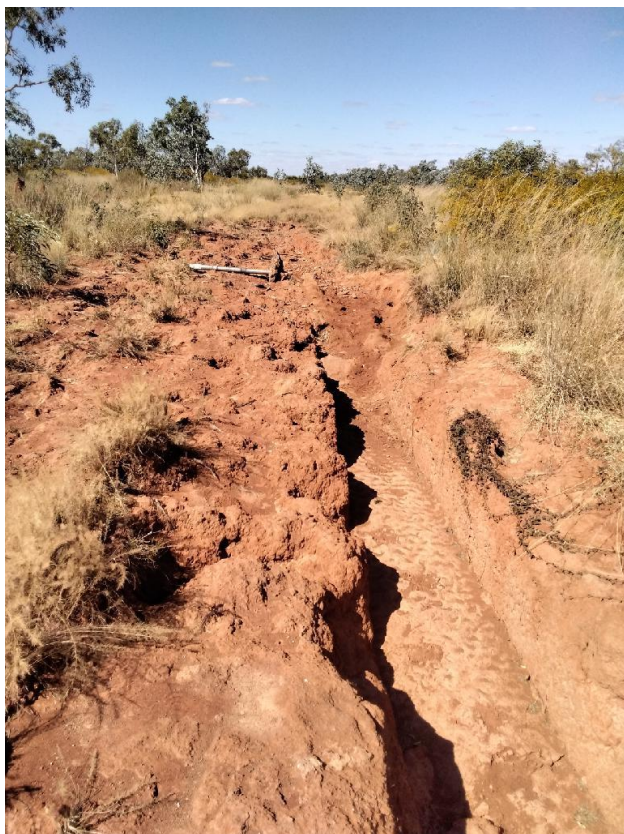
Figure 21. Significant subsidence up to a metre deep at KP 25 where runoff follows the pipeline trench.

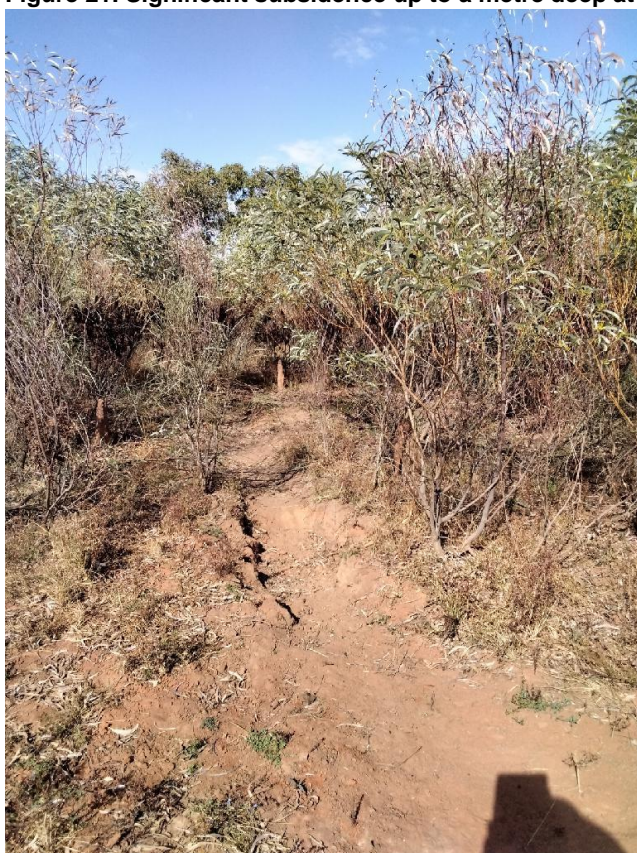
Figure 22. Minor erosion caused by cattle tracking KP 87.1

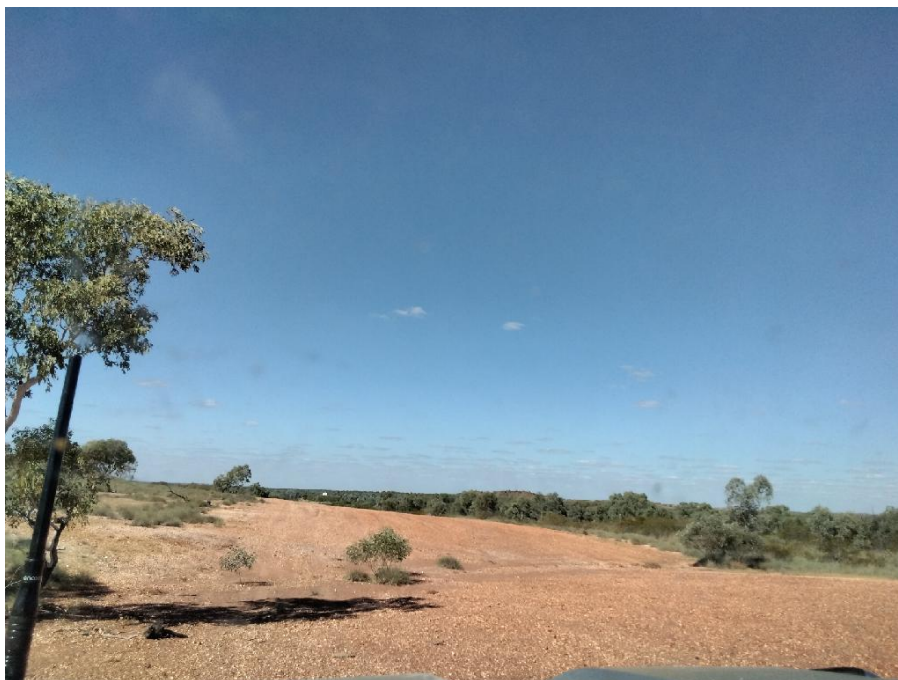
Figure 24. Revegetation score of 2 - bare gravel, very sparse ground and shrub cover.
