NGP ANNUAL COMPLIANCE REPORT - 2021

Jemena Northern Gas Pipeline Pty Ltd (ACN 607 928 790)

JEMENA
NORTHERN GAS PIPELINE
TRANSITIONAL REHABILITATION ASSESSMENT
REPORT

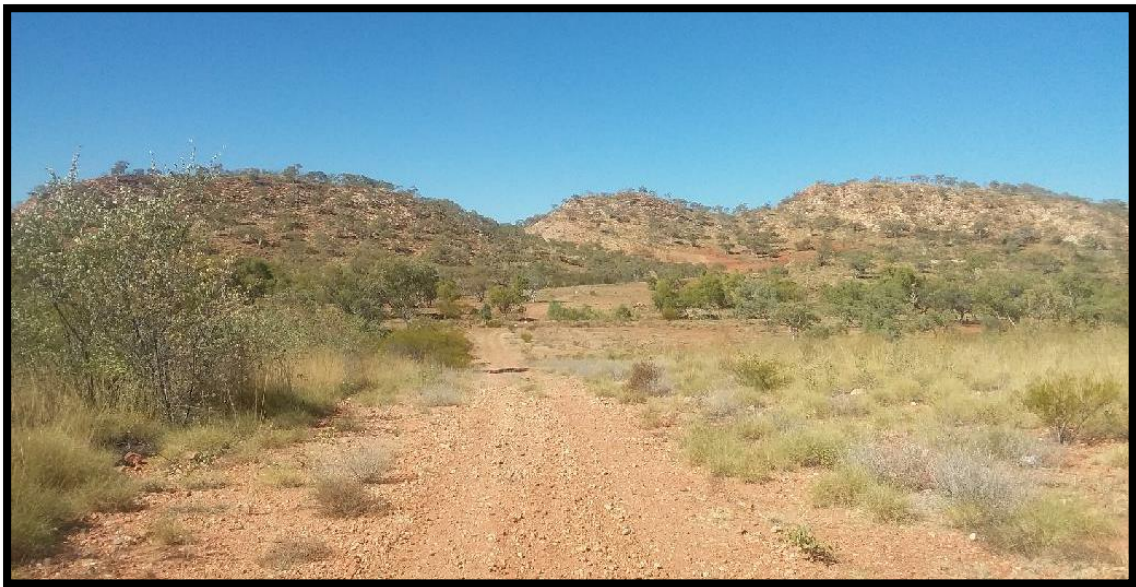
Trafficable access track on edge of stable well vegetated pipeline KP615

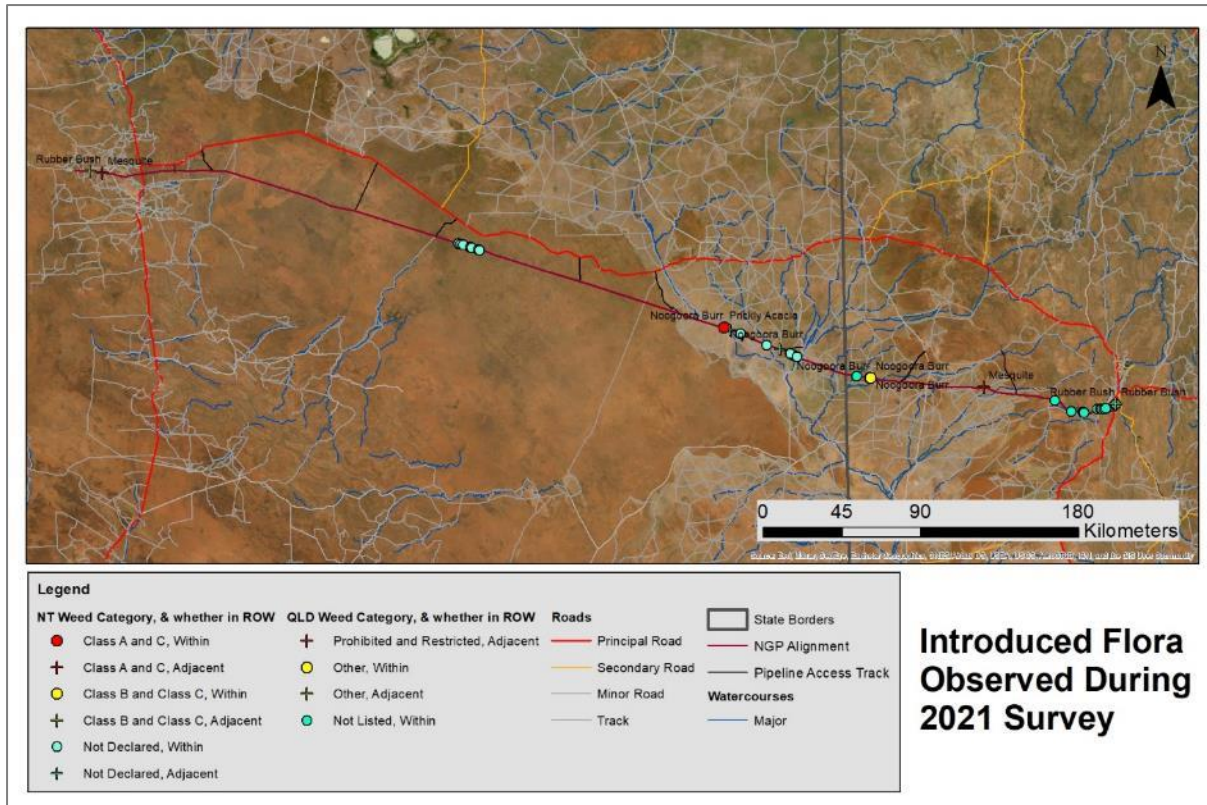
A map of the introduced flora species observed during the survey is presented in Figure 5 below. Observation points are displayed by weed category and whether they were growing inside the pipeline ROW or on land adjacent to the ROW.

Figure 5: Map of introduced flora species observed during the survey, displayed by weed category.

It is recommended that Jemena continue to undertake control of areas of weed incursion within the disturbed areas. Jemena should also consider working with adjacent landholders to control weeds immediately adjacent to the pipeline ROW to reduce likelihood of spread from adjacent land onto the ROW. Control of declared weeds within the ROW should be prioritised. Future monitoring should reinspect these locations to ensure control has been effective and weeds have not spread.

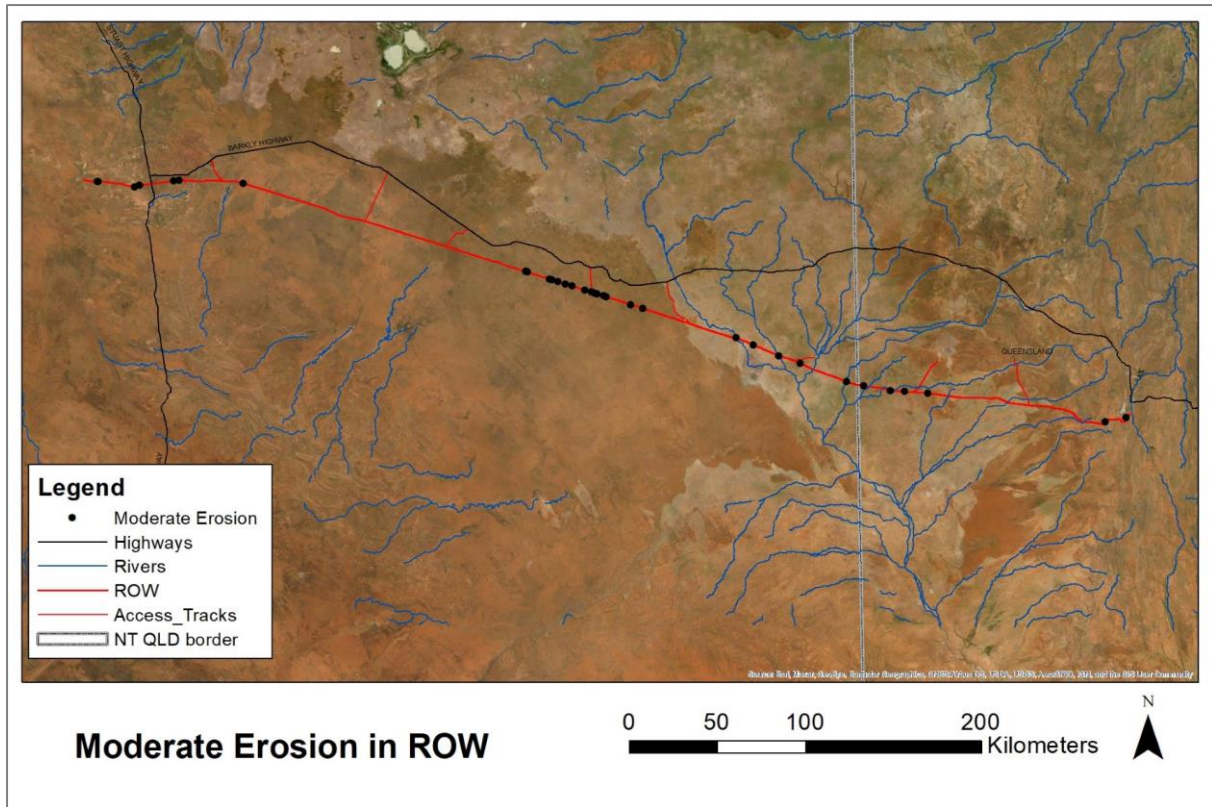
Figure 10 Map showing location of moderate erosion observed

The current condition of the observed erosion along the ROW was predominately at a minor level. A small percentage of the erosion occurrences were advancing to a moderate level. Most of the erosion has occurred along the access track within the ROW. The rest of the ROW appeared to be relatively stable. Cattle tracking along the access track and the pipeline intensified water channelling and erosion in some places. However, this was also observed outside of the ROW. There were 34 locations/areas where moderate erosion was observed and 142 locations where minor erosion was observed along the 622km pipeline ROW. To prevent the minor and moderate erosion from advancing further, and channelling more water and removing greater amounts of topsoil, monitoring and some works are recommended.

Refer to Figure 10 for the moderate erosion locations. Refer Appendix 7.1 for summary table with locations and recommended actions.

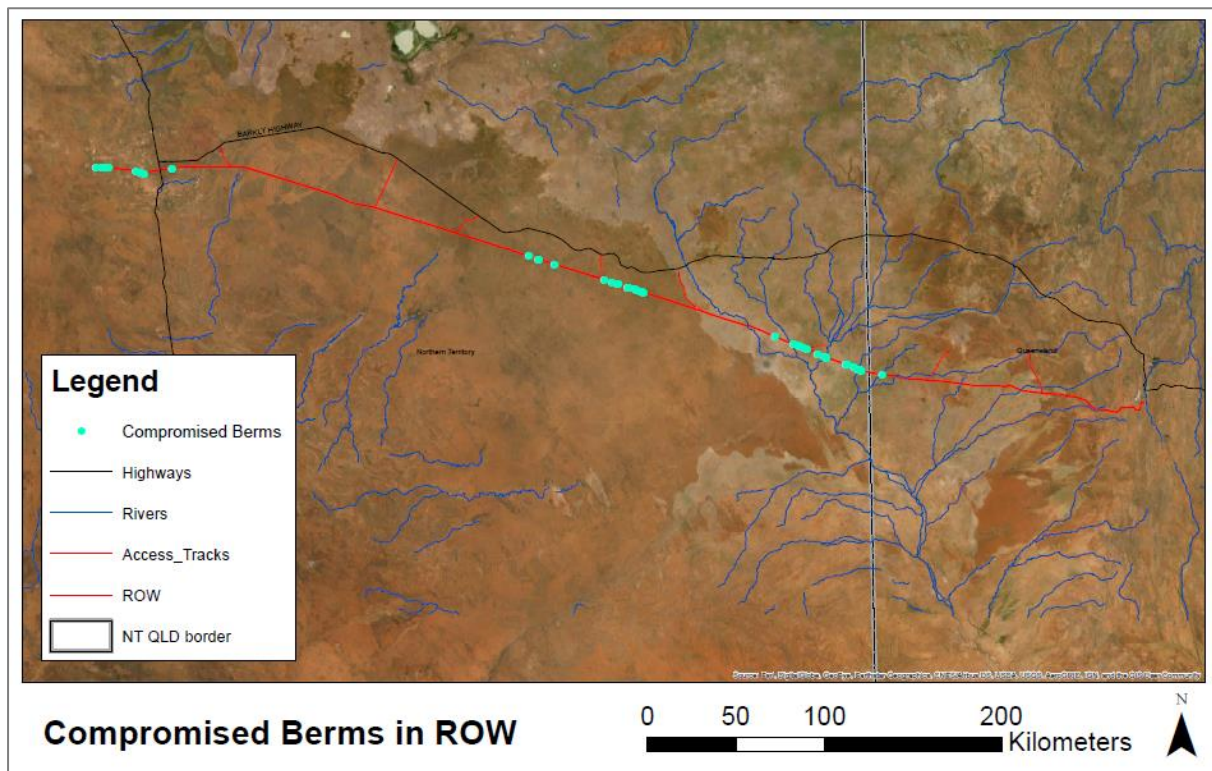
Figure 17 Map of Compromised Berm Locations

The map in Figure 17 below shows the locations of areas of observed compromised berms along the Northern Gas Pipeline. Refer Appendix 7.1 for a summary table of compromised berm observation points with GPS coordinates.

- Repair existing compromised berms, and make them more robust as appropriate.
- Extend most of the berms, to more effectively divert water beyond the ROW. Currently water is often flowing around the end of the berms and continuing down the track.
- Construct additional berms in areas with susceptibility to water flow and erosion.
- Raise the height of some of the berms to dissuade cattle.

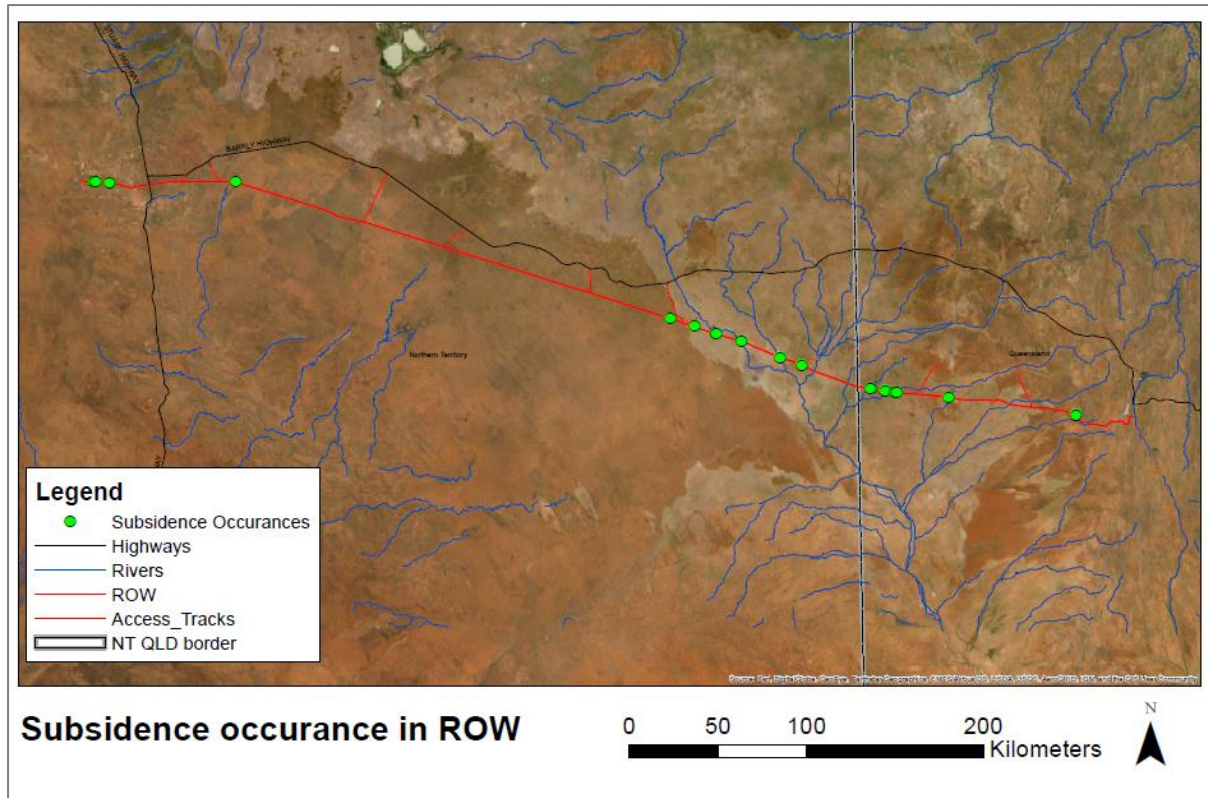
Figure 19: Map showing locations of observed subsidence

The map in Figure 19 below shows the locations of observed subsidence along the Northern Gas Pipeline. Refer Appendix 7.1 for a summary table of subsidence observation points with GPS coordinates.

- Where appropriate, back fill subsidence to ground level.
- Repair nearby berms and/or add additional berms up slope of subsidence locations where water has been tracking along subsided trench.

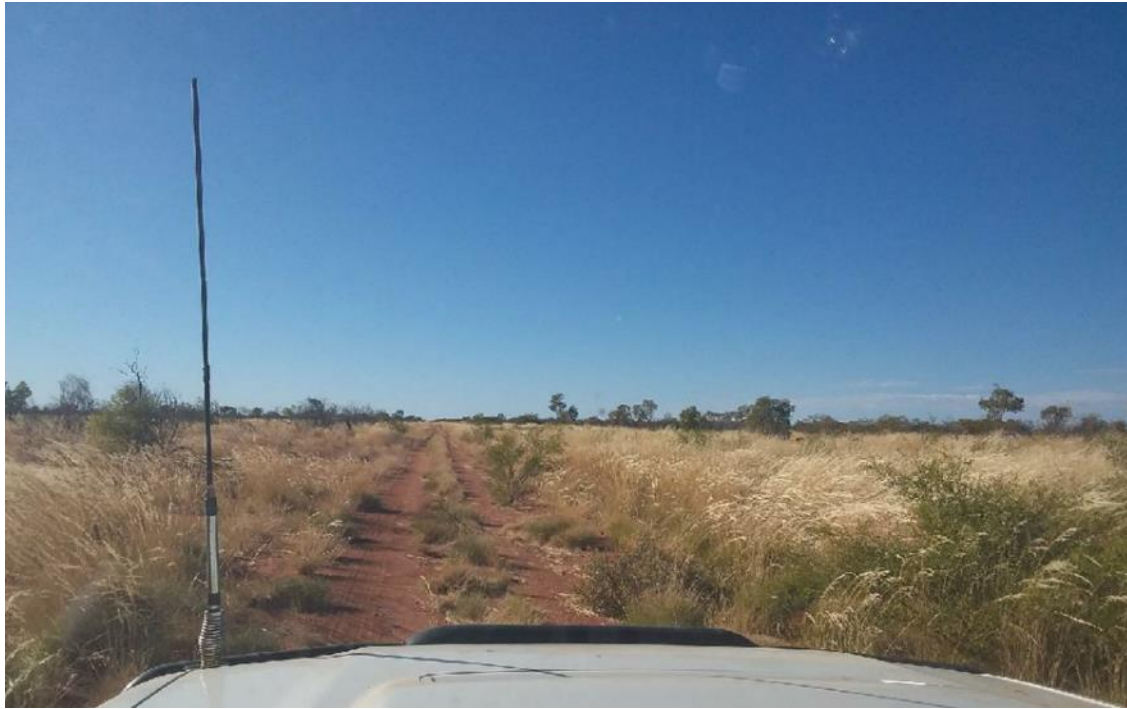
Overall the 622 km long ROW for the Northern Gas Pipeline is rehabilitating well. The pipeline traverses several different land systems contained within different IBRA bioregions. Across all land systems there are signs of revegetation and plant re-entry into the site, with growth across tree, shrub and grass layers. In the Desert dune fields and sand plains of the Wonorah and Yelvertoft land systems revegetation is dominated by *Acacia lysiphloia* and *Acacia stipuligera*. These fast growing species respond well to disturbance and have densely colonised the cleared pipeline area. In these areas over story trees include *Corymbia Opaca* and *Eucalyptus Victrix*. Across these desert soils Spinifex (*Triodia spp*) dominated understory revegetation and is present along large sections of the pipeline (see figure 1.). In the cracking clay soils of the Austral and Wonardo land systems revegetation is slower with the dominant species Mitchell grass (*Astrelba pectinata*) gradually re-entering the site in some areas. Flinders grass (*Iseilema vaginiflorum*) is also common in these areas. Across the steeper slopes of the Bundella, Waverly and Mount Isa land systems revegetation is dominated by *Eucalyptus brevifolia*, *Acacia spp* and *Spinifex spp*, with strong growth along low lying areas and around water courses.

Figure 22. Spinifex revegetation
