NGP ANNUAL COMPLIANCE REPORT - 2023

JEMENA
NORTHERN GAS PIPELINE
TRANSITIONAL REHABILITATION ASSESSMENT
REPORT 2023

June 2023

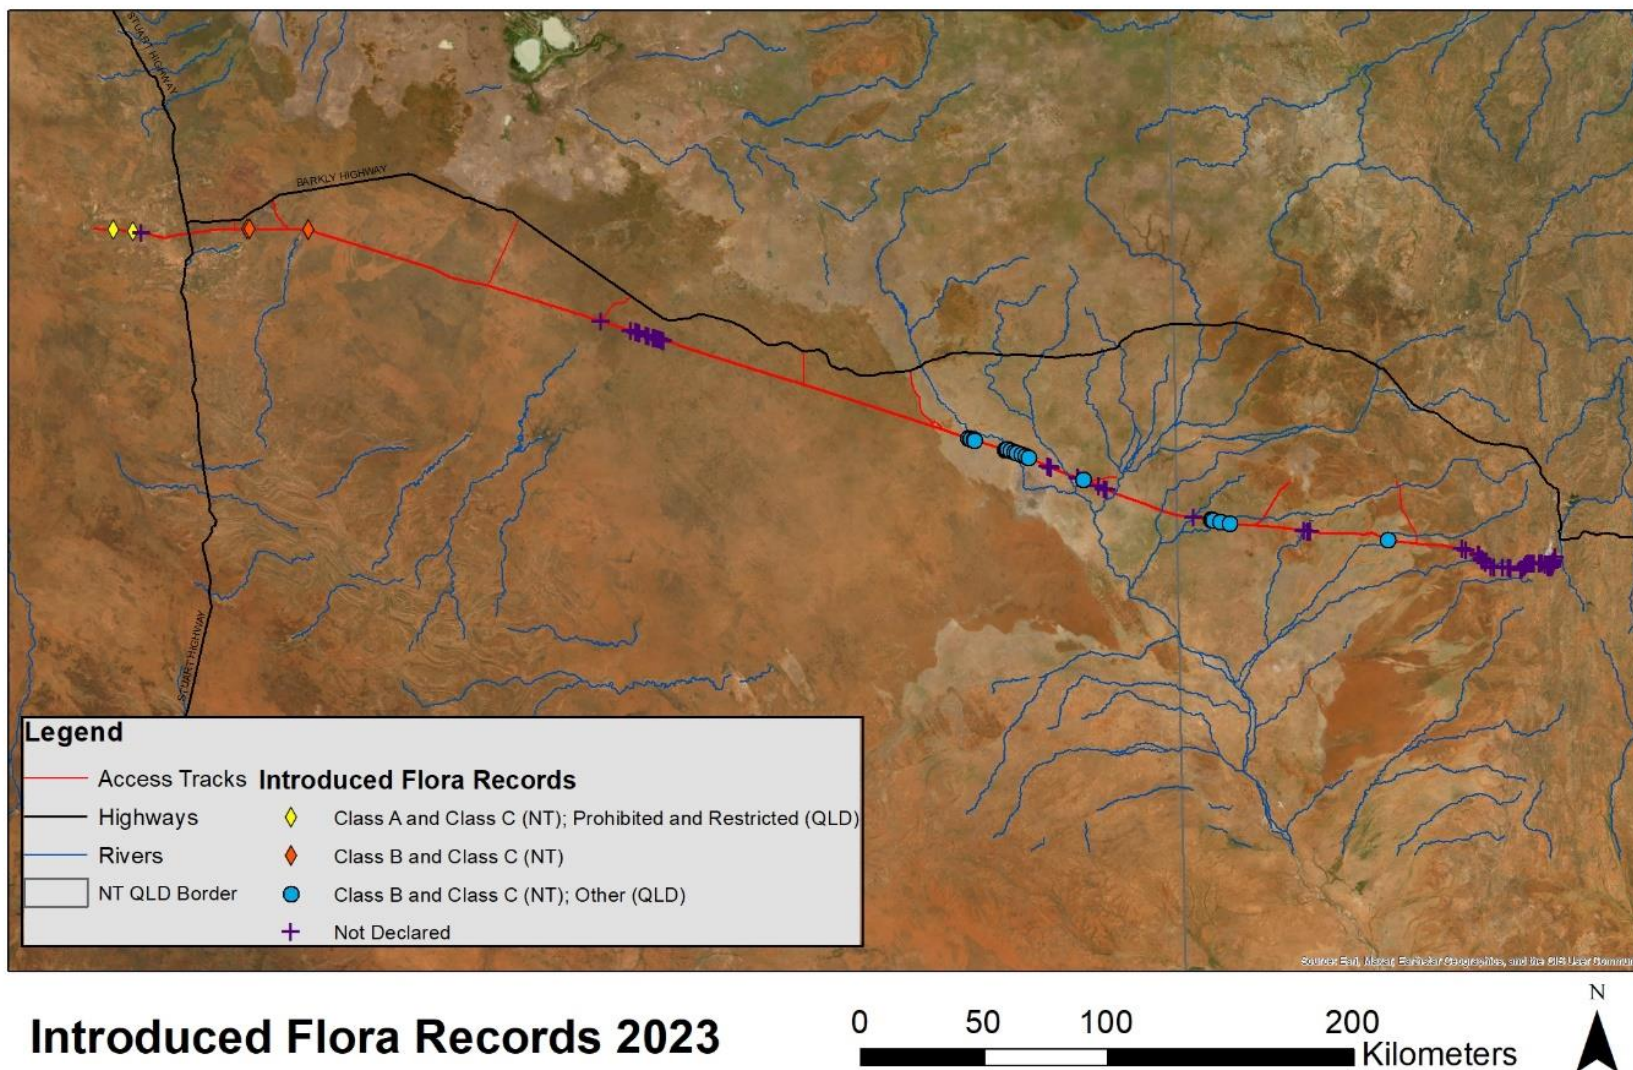
Figure 5. Map of introduced flora species observed during the survey, displayed by weed classification

Cenchrus ciliaris (Buffel Grass) has spread from adjacent land and begun to establish within the pipeline easement in small but dense patches at KP 211.3 and KP 237.7. *Cucumis myriocarpus* (Paddy melon) was found in small populations at KP 19.3 and KP 511.4. *Trichodesma zeylanicum* (Cattle Bush) was found in a small population at KP 233.5. *Malvastrum americanum* (Spiked Malvastrum) was only found in a small population at KP 403.3.

A map of the introduced flora species observed during the survey is presented in Figure 5 below.

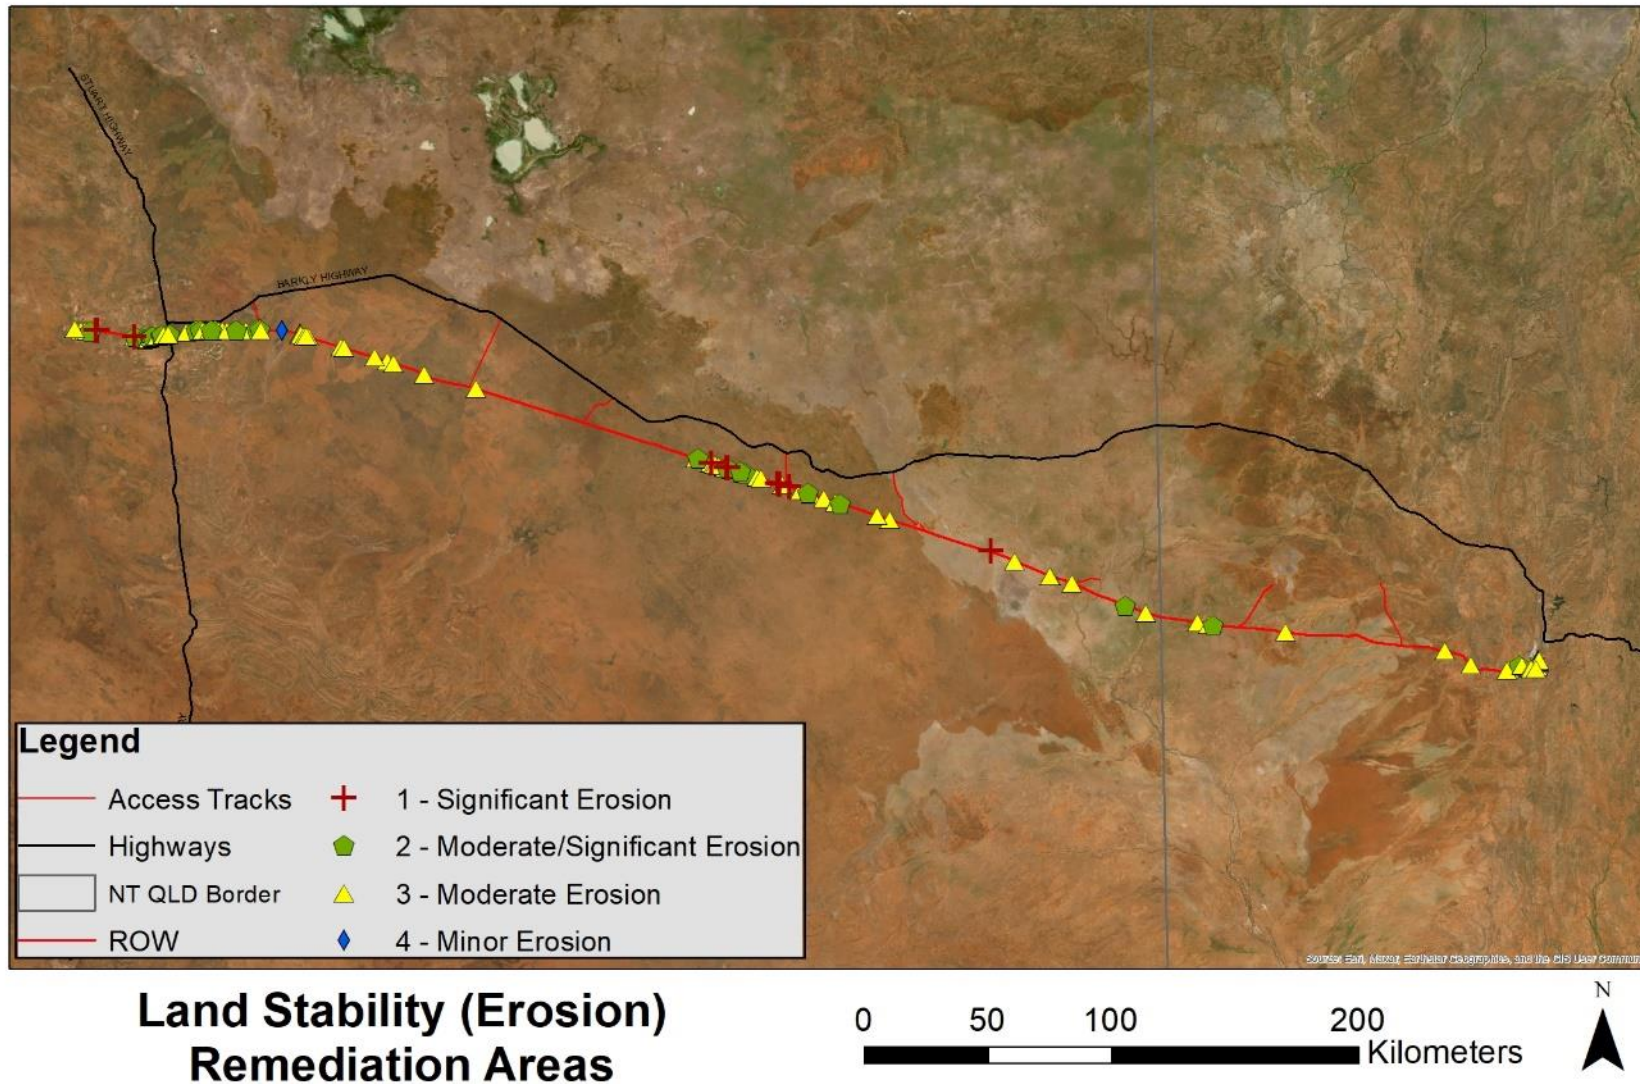
Figure 10. Map showing location of significant, moderate/ significant, moderate, and minor erosion

All locations of erosion issues where remediation actions are recommended are presented in Figure 11.

Refer to Figure 11 for significant and moderate erosion locations. Refer Appendix 8 for summary table with locations and recommended actions.

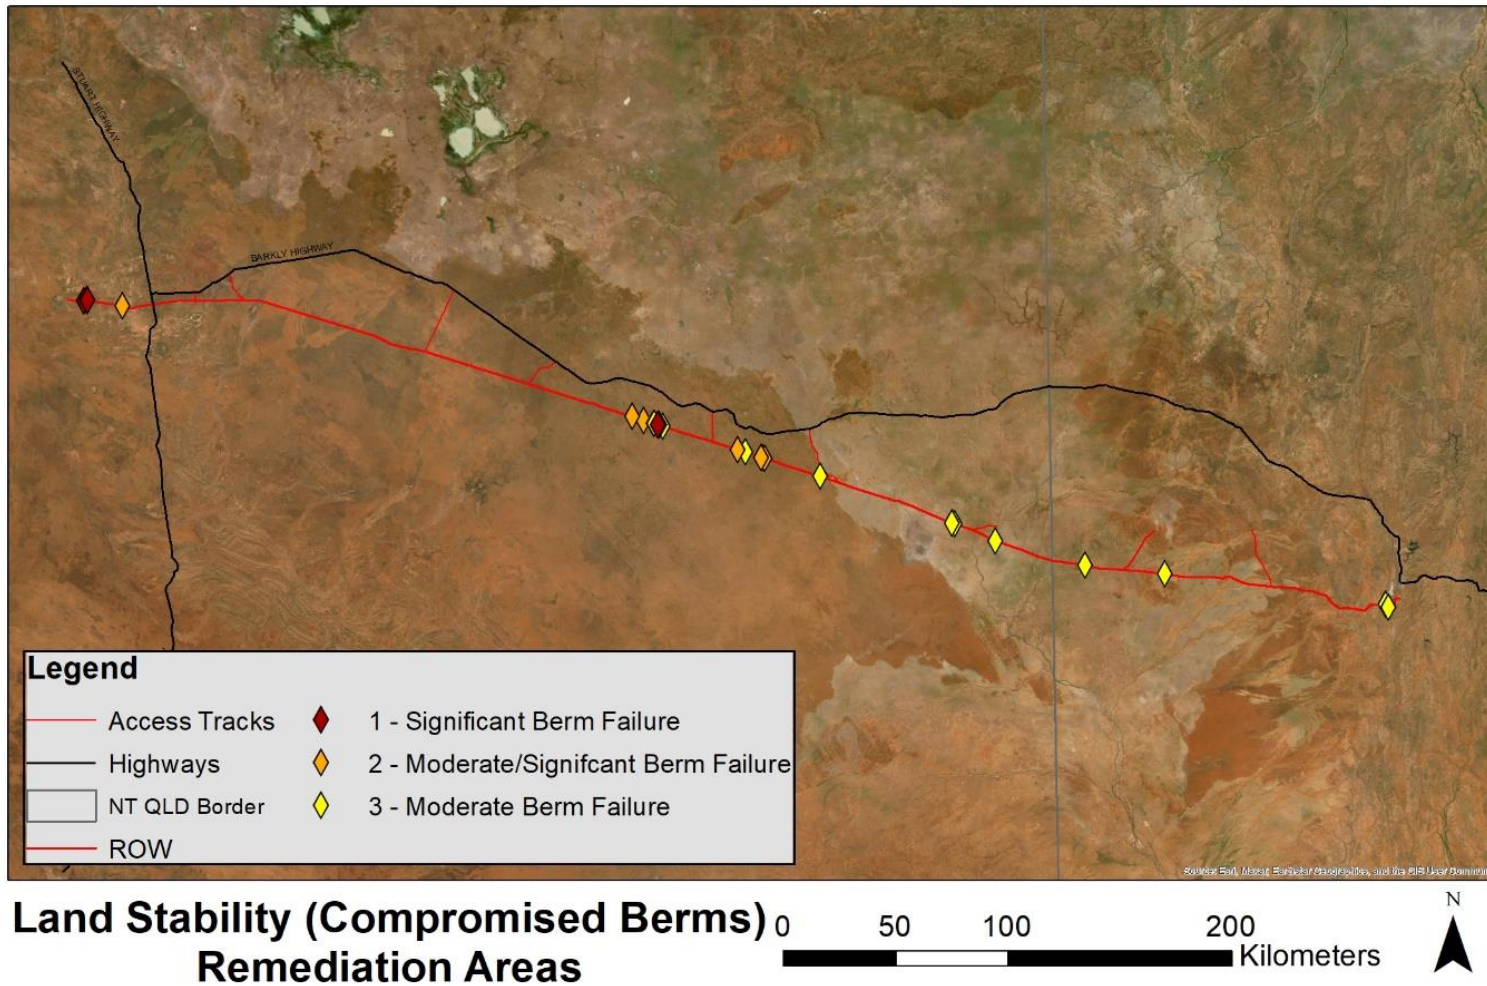
Figure 17. Map of observed Compromised Berm locations.

Many of the berms would be more effective if they extended beyond the disturbed area of the ROW easement to divert and disperse water out onto the adjacent undisturbed land. LES understands that due to constraints associated with heritage buffers at the time the berms were constructed, berms could not be constructed to extend outside the ROW. In places where the access track runs along the edge of the ROW, berms only extend to the edge of the ROW and do not divert the water flow beyond the track edge, but rather water flows around the end of each berm and continues channelling downslope along the track creating erosion.

The map in Figure 17 below shows the locations of observed compromised berms along the Northern Gas Pipeline. Refer Appendix 8 for summary table with locations and recommended actions.

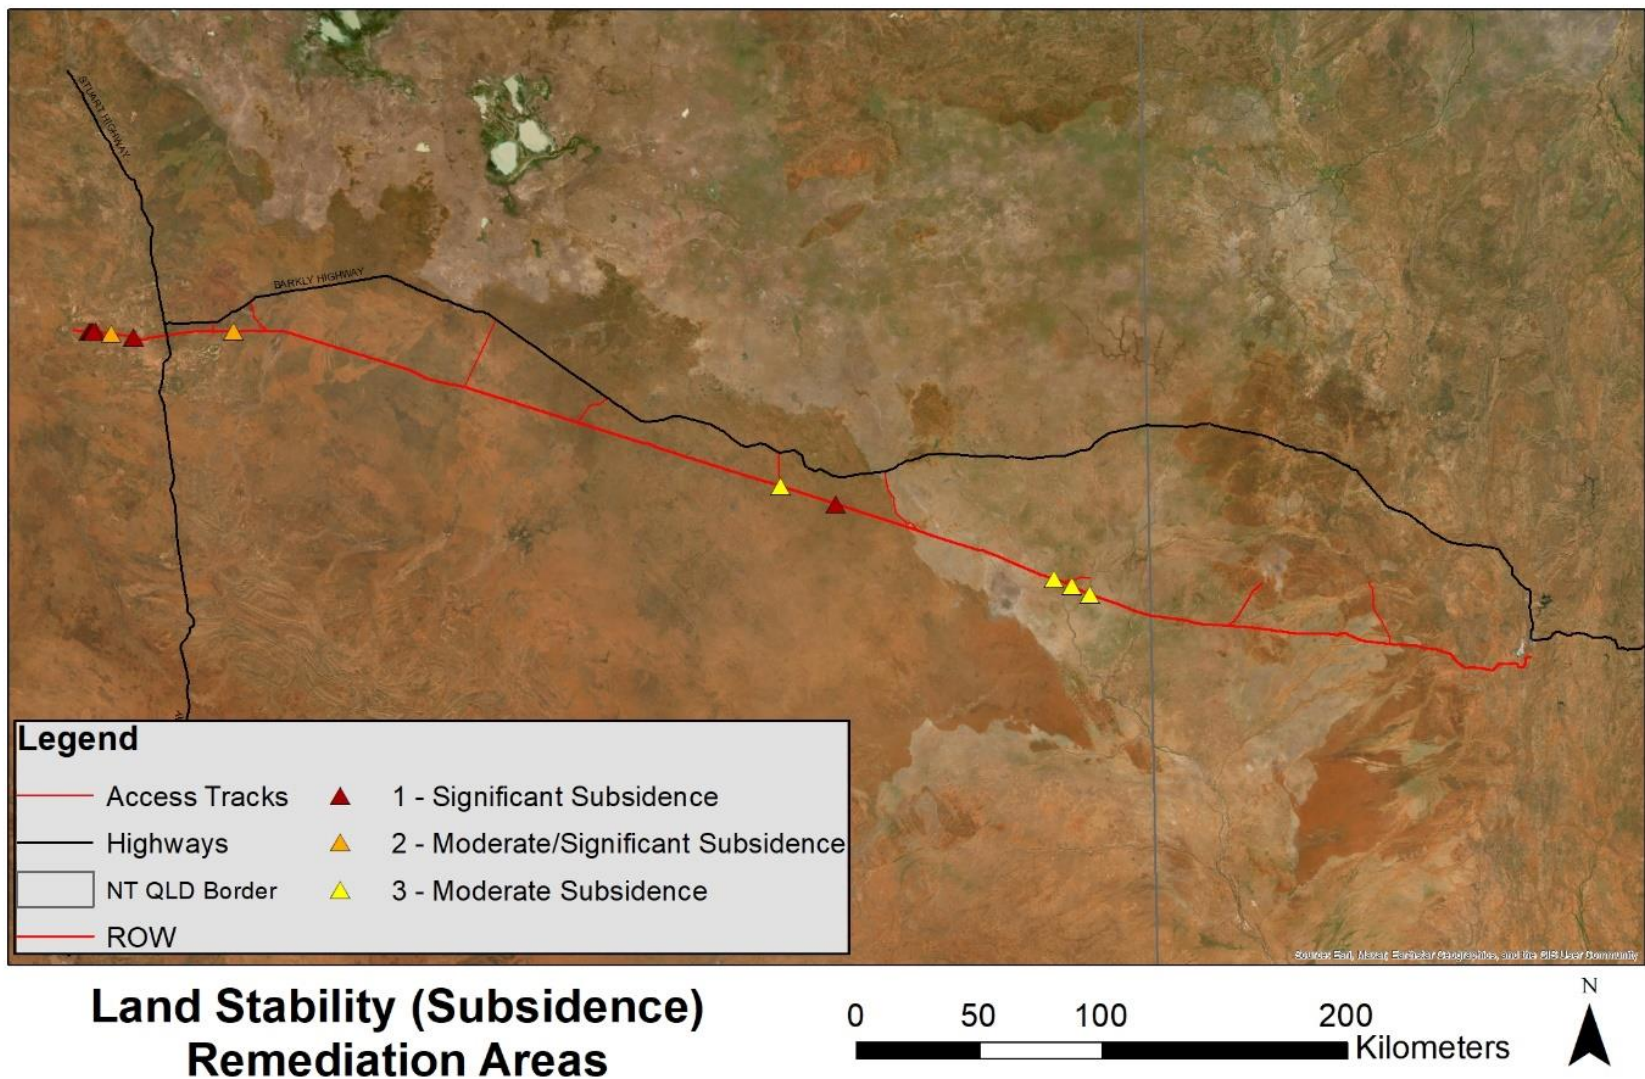
Figure 20. Map showing locations of observed subsidence.

Subsidence issues were recorded at 19 locations along the ROW, all associated with water channelling directly along the pipeline trench. Most subsidence issues were considered significant (eight instances) or moderate (12), ranging from 500 mm to 1 m in depth. To prevent water channelling and eroding the pipeline trench reinstatement or construction of runoff diversion berms are recommended in most cases, with a few minor issues requiring monitoring.

The map in **Error! Reference source not found.**20 below shows the locations of observed subsidence along the Northern Gas Pipeline, mostly in the western desert areas, but also in the steeper section near the eastern end of the pipeline. Refer Appendix 8 for summary table with locations and recommended actions.

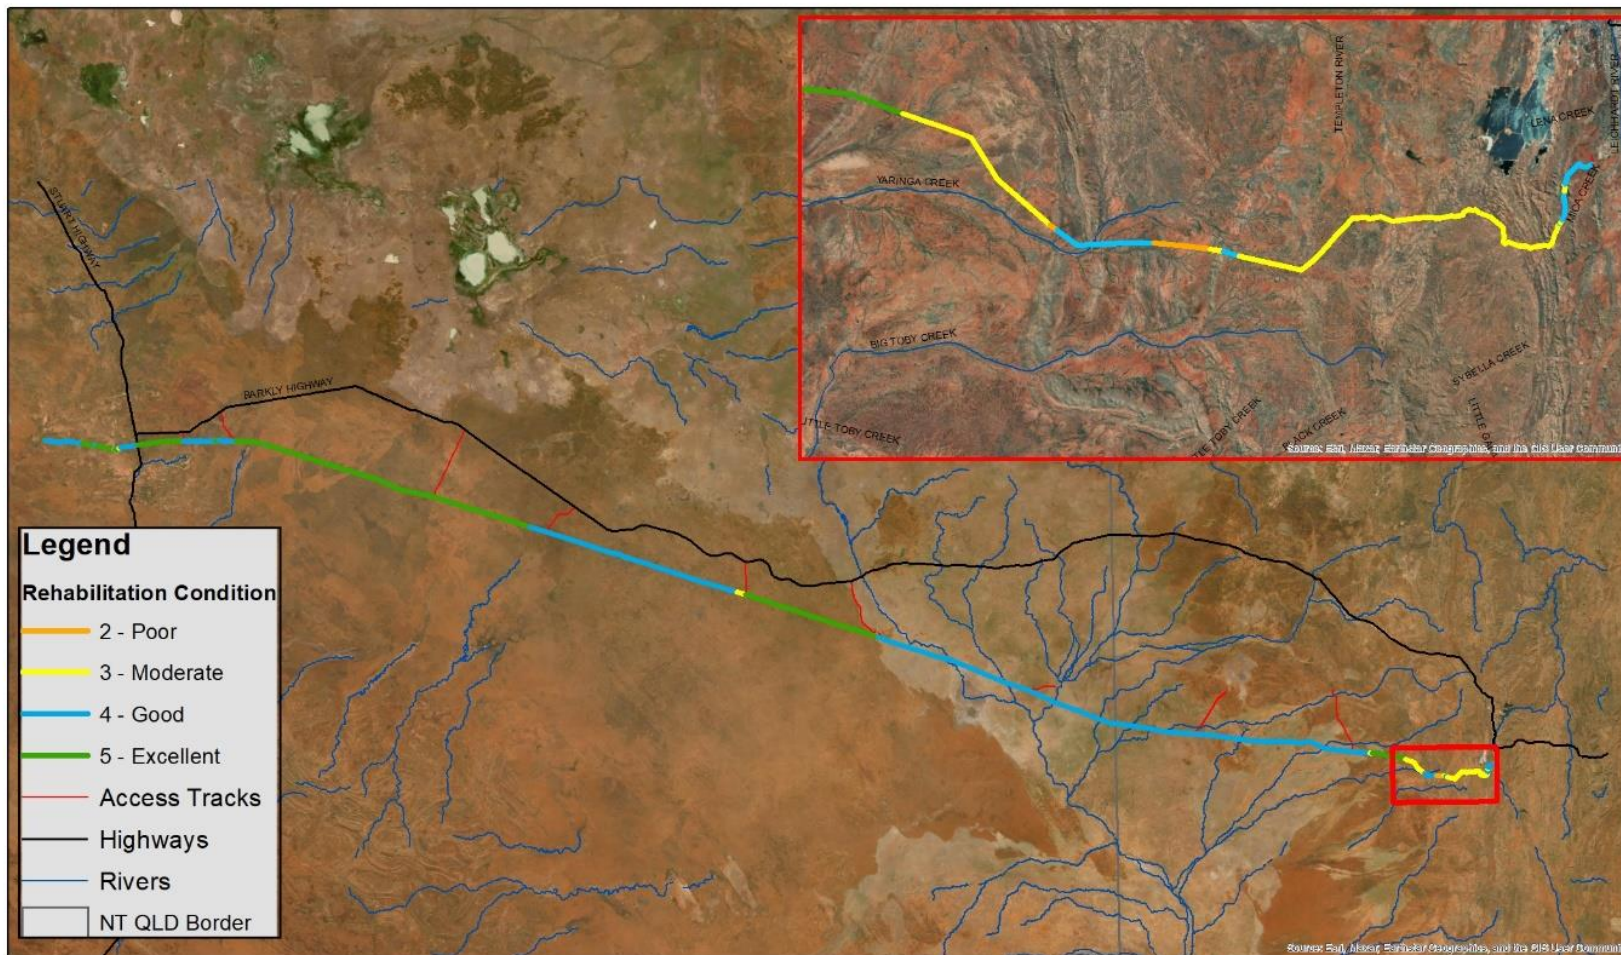
Figure 23. Map showing rehabilitation conditions along the pipeline.

Quality of habitat for the threatened Plains Death Adder found between approximately KP 355 and KP 561 of the ROW, is reflected by the revegetation scores through this area which show revegetation is good or excellent and habitat for the Plains Death Adder appears to be the same, but with cracks in the clay soils perhaps not quite so pronounced as in the adjacent clay soils . Revegetation was also reflective of surrounding vegetation, even where it was in early successional phase.

The map in **Error! Reference source not found.**²⁴ below shows the conditions of revegetation along the Northern Gas Pipeline.

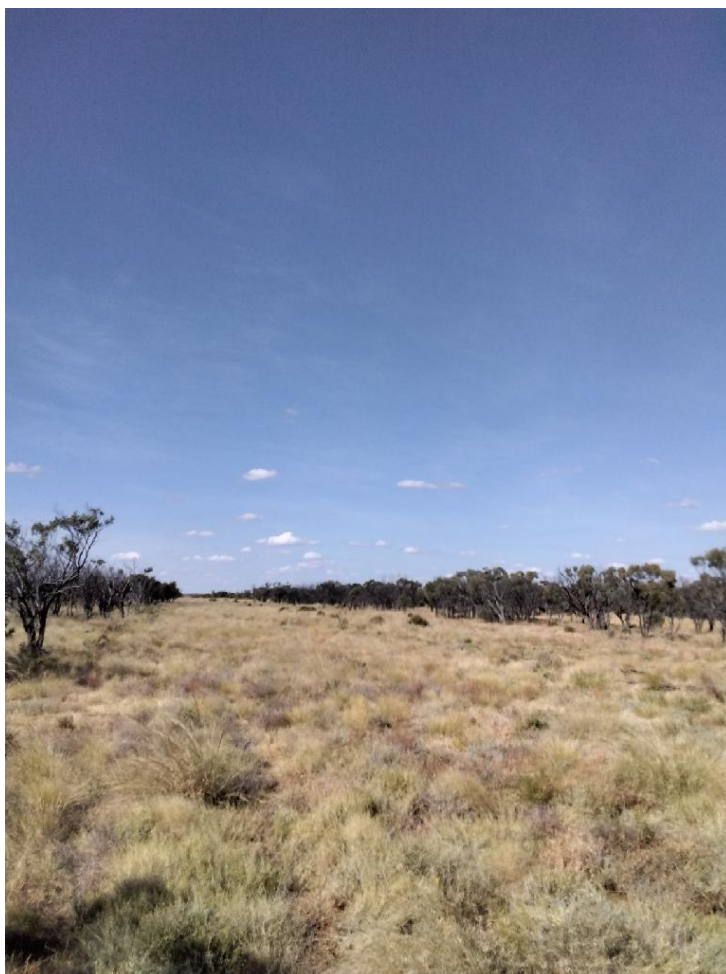
Figure 25.. Revegetation score of 3 – Good ground cover, sparse shrubs, no canopy

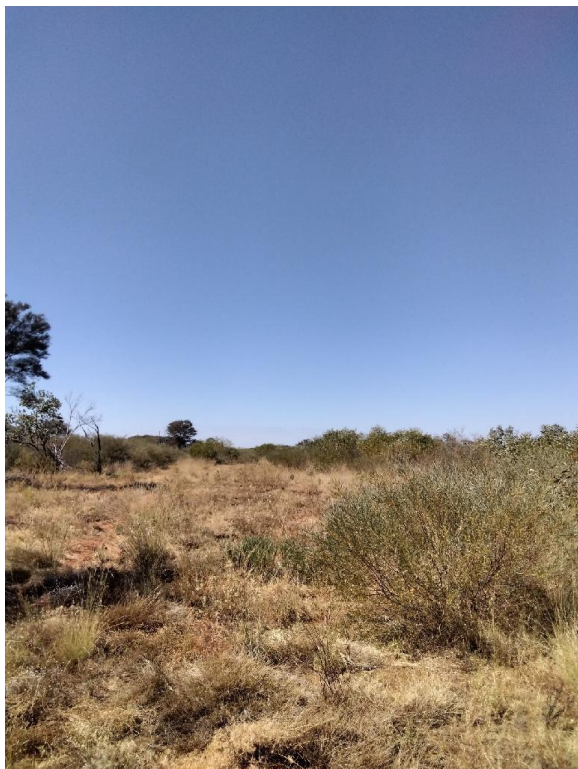
Figure 26. Revegetation score of 4 – Good ground and shrub cover

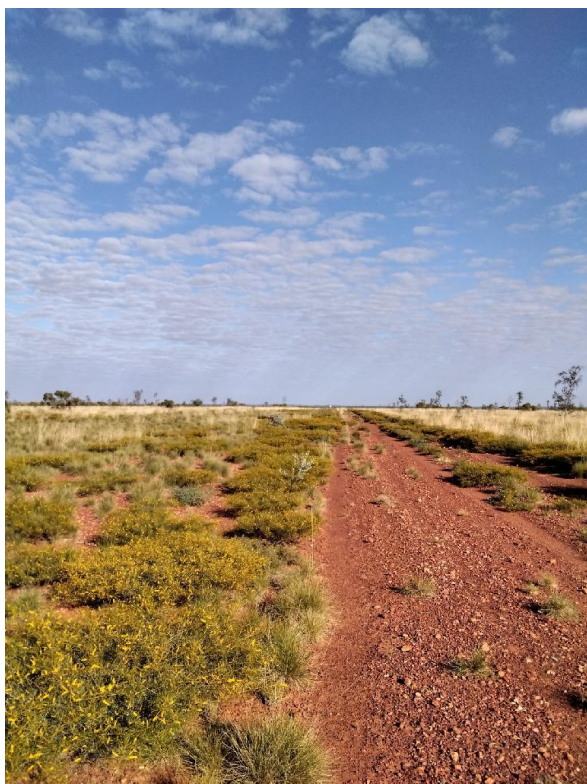
Figure 27. Revegetation score of 5 – Excellent revegetation
